**Home Inspections For A Better Peace Of Mind.**

**123 Homebuyer Road, Homebuyers Town, Victoria, 3000**

Report/Agreement #              Combined Building & Timber Pest Inspection Report  
 Inspection Date:                  02 Jan 2023  
 Inspection Time:                  07:00

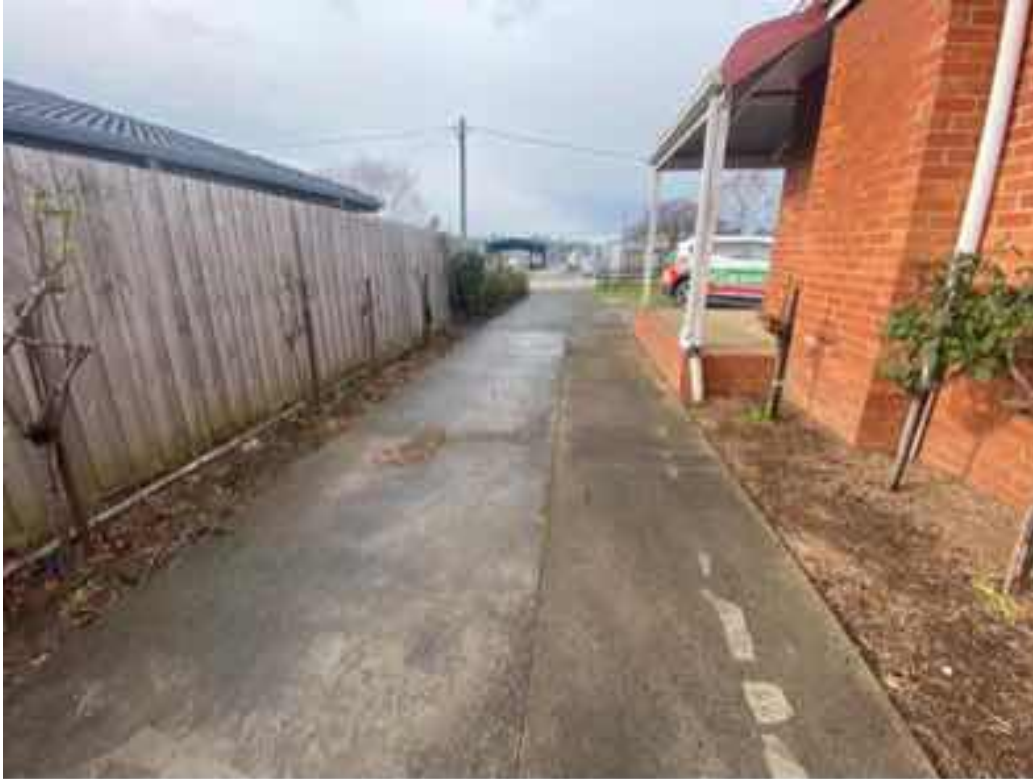
Driveway has visible tripping hazards. Repairs are required by a qualified concreter to avoid potential injury. Considered a Safety hazard

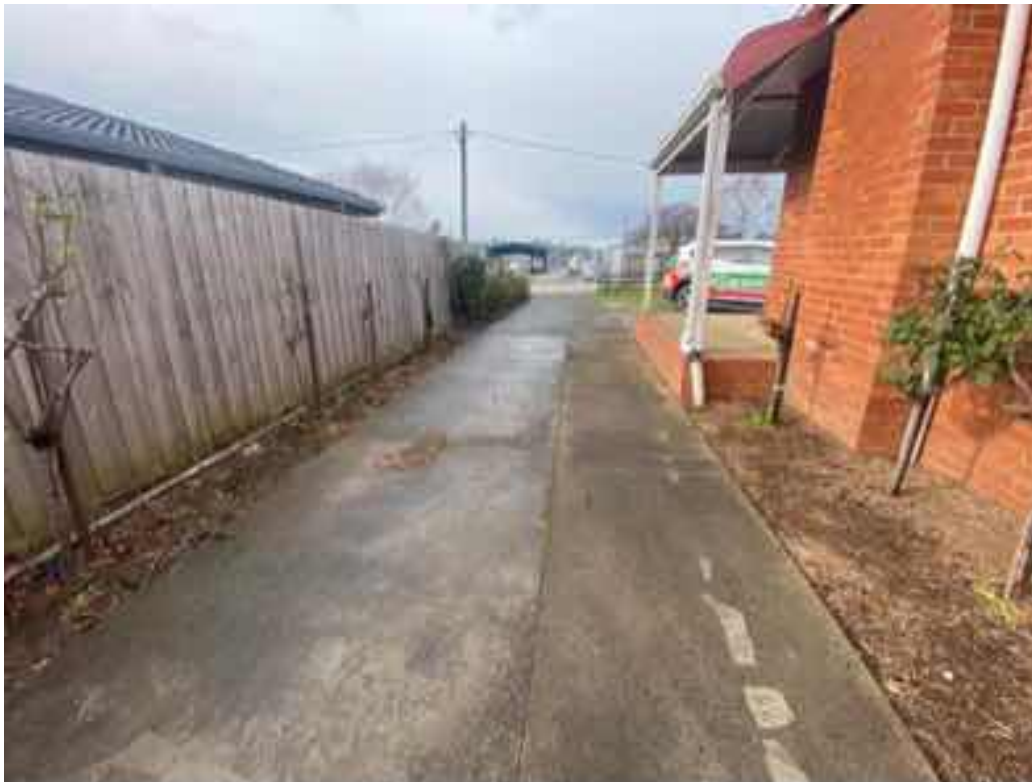
There is evidence around the Driveway that ponding near walls has occurred. Recommendations: A qualified landscaping contractor or a plumber should be engaged for advice and recommendations.

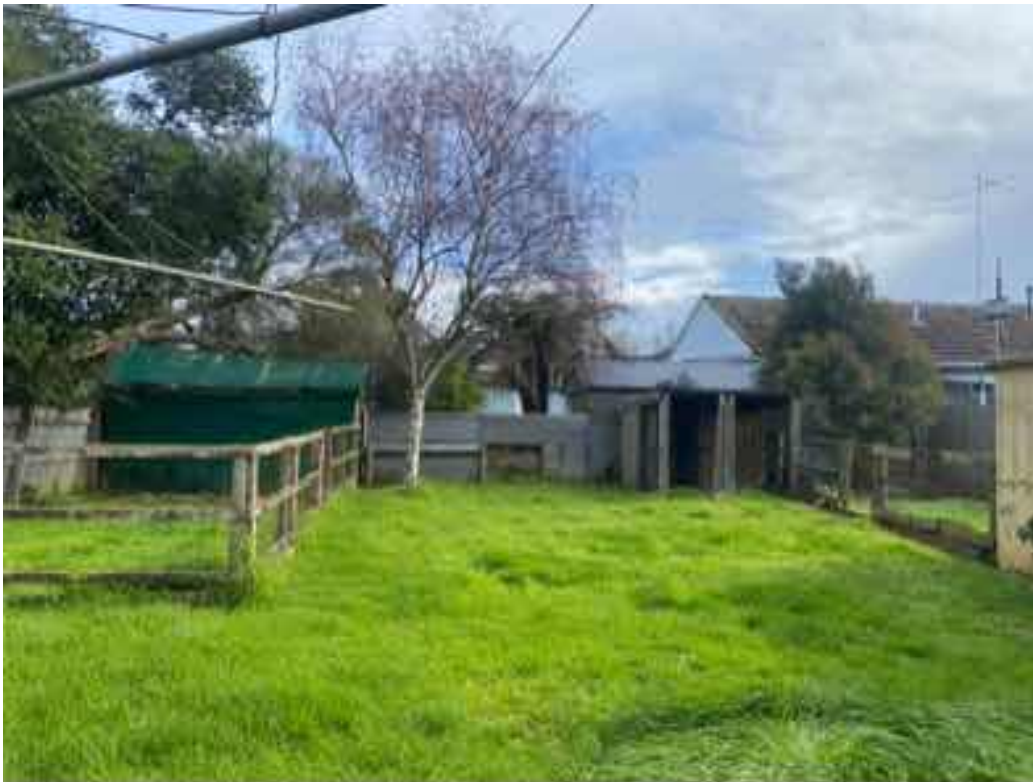
The shed is considered in poor condition and repairs/replacement should be considered. A replacement shed should be considered.

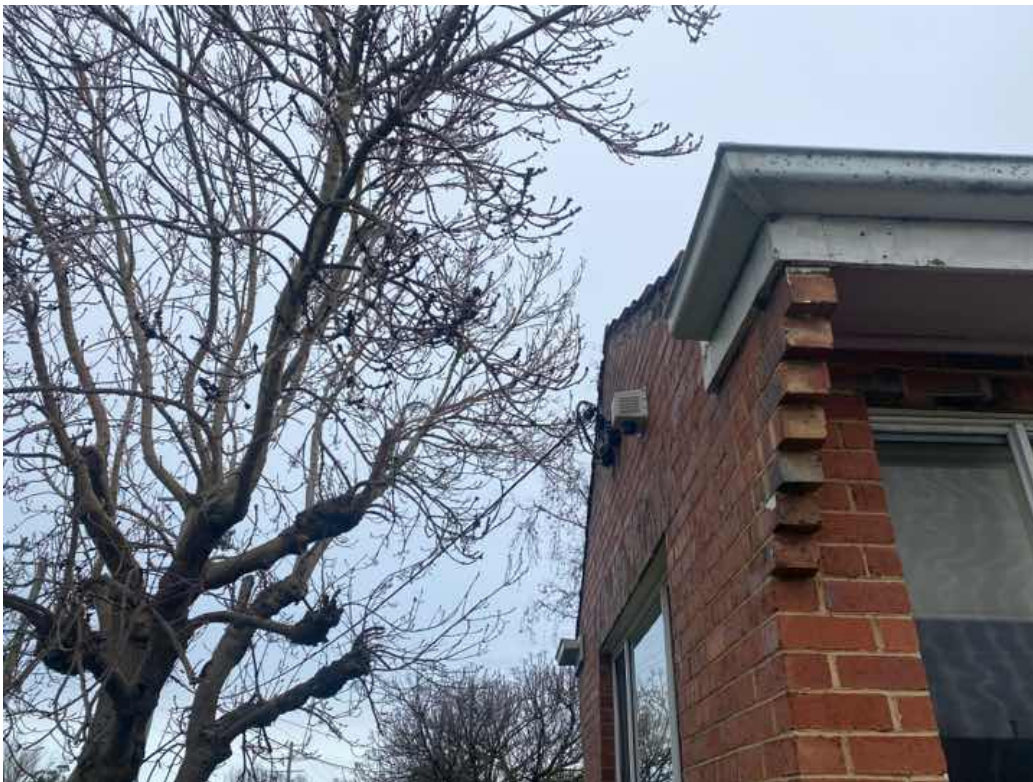
Trees are overhanging roof areas. Recommendations: These should be cut back away from the roof line and gutters.

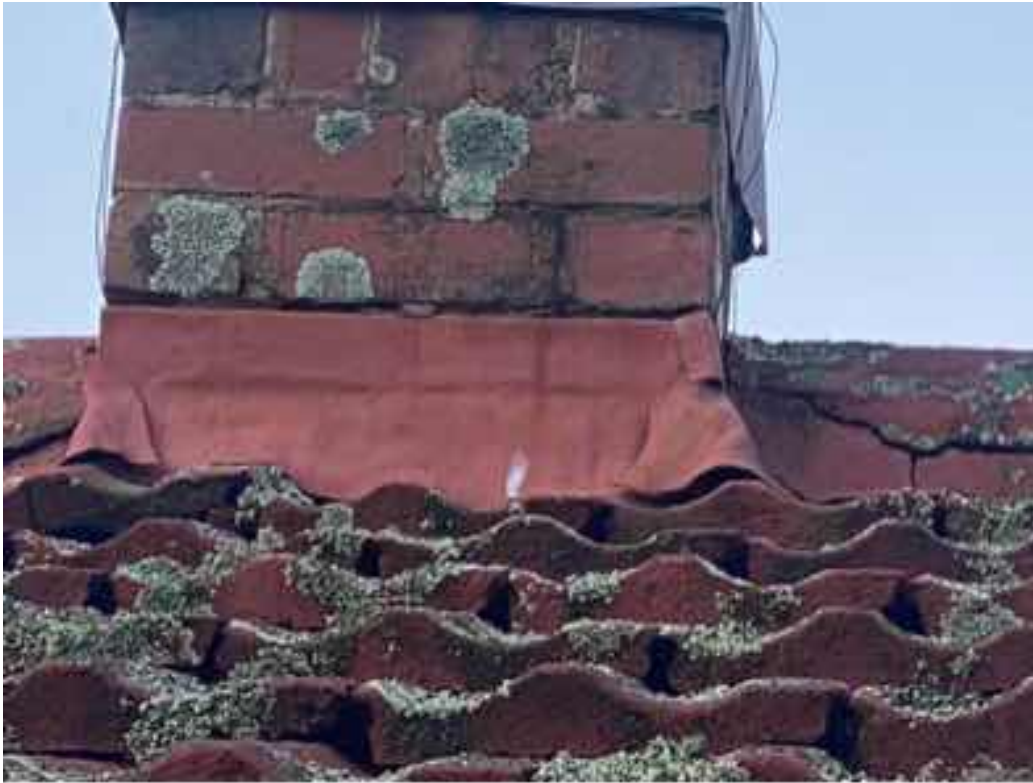
Minor flashing rust sections - Recommendations: A qualified roofer should be engaged for repairs and recommendations.

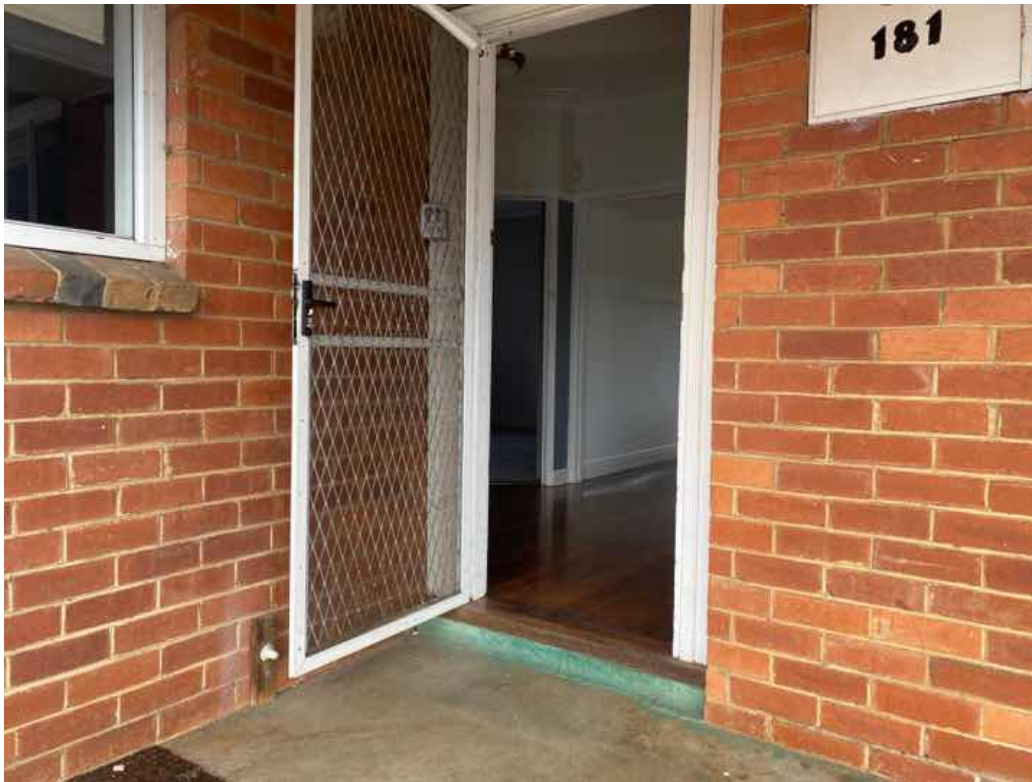
Security flyscreen damage- recommendations: A qualified carpenter should be engaged for advice and recommendations.

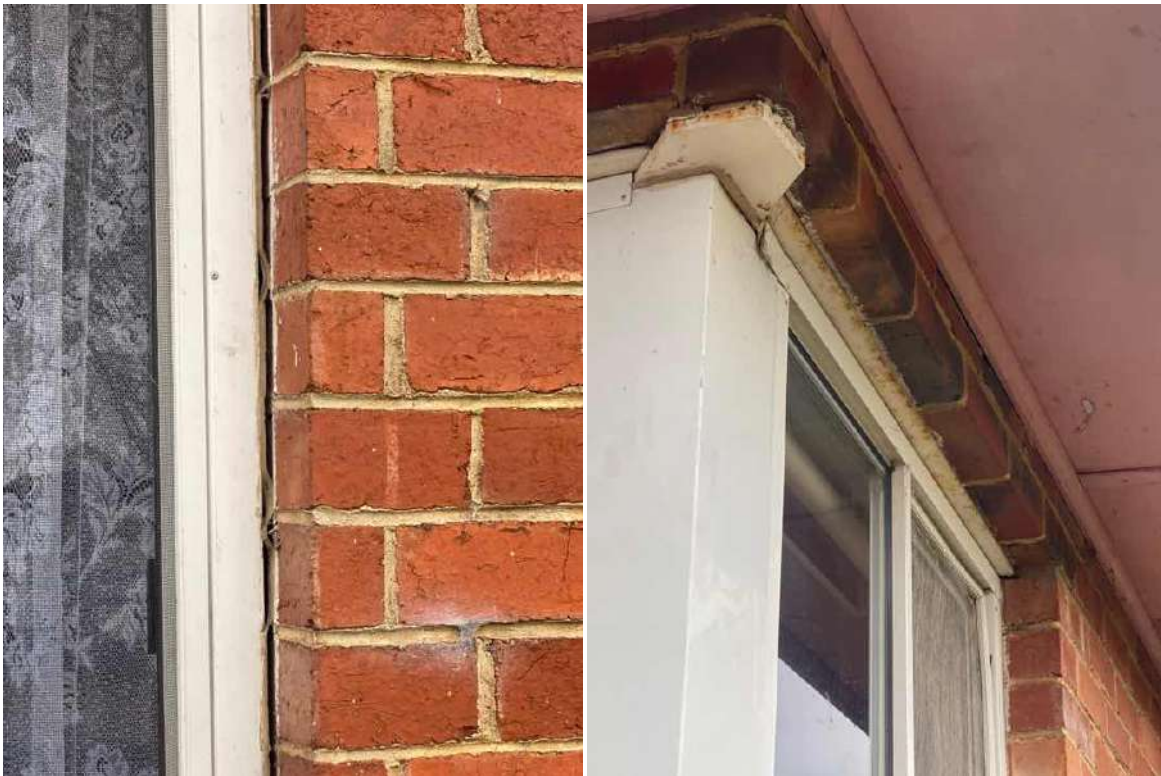
Lintel rust in sections. This may cause cracking in wall linings above the window - Recommendations: A qualified brick layer should be engaged for repairs and recommendations.

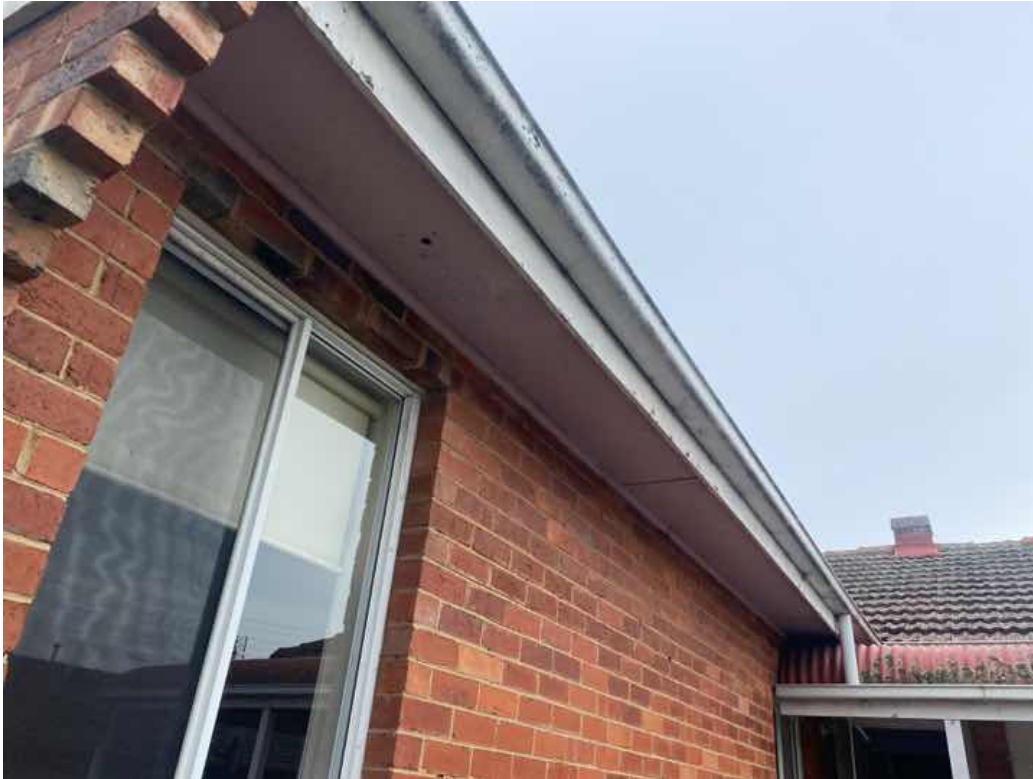
Possible Asbestos seek expert advice from a Asbestos company.

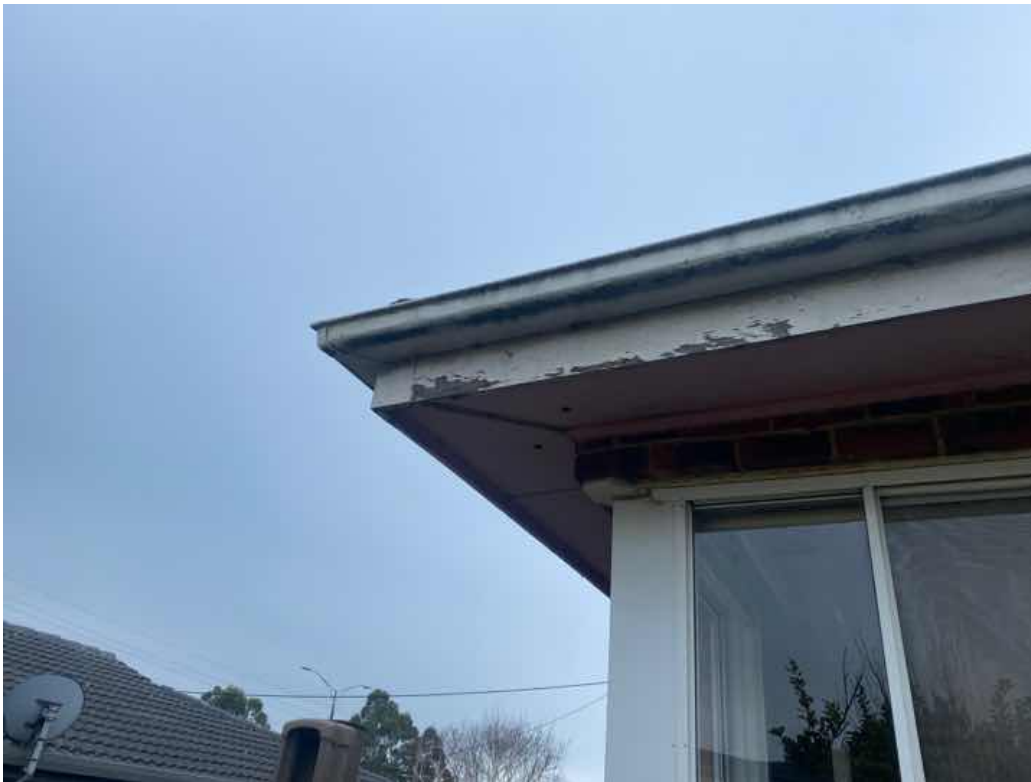
Separated on corner. Recommendations: A qualified carpenter should be engaged for advice and recommendations.

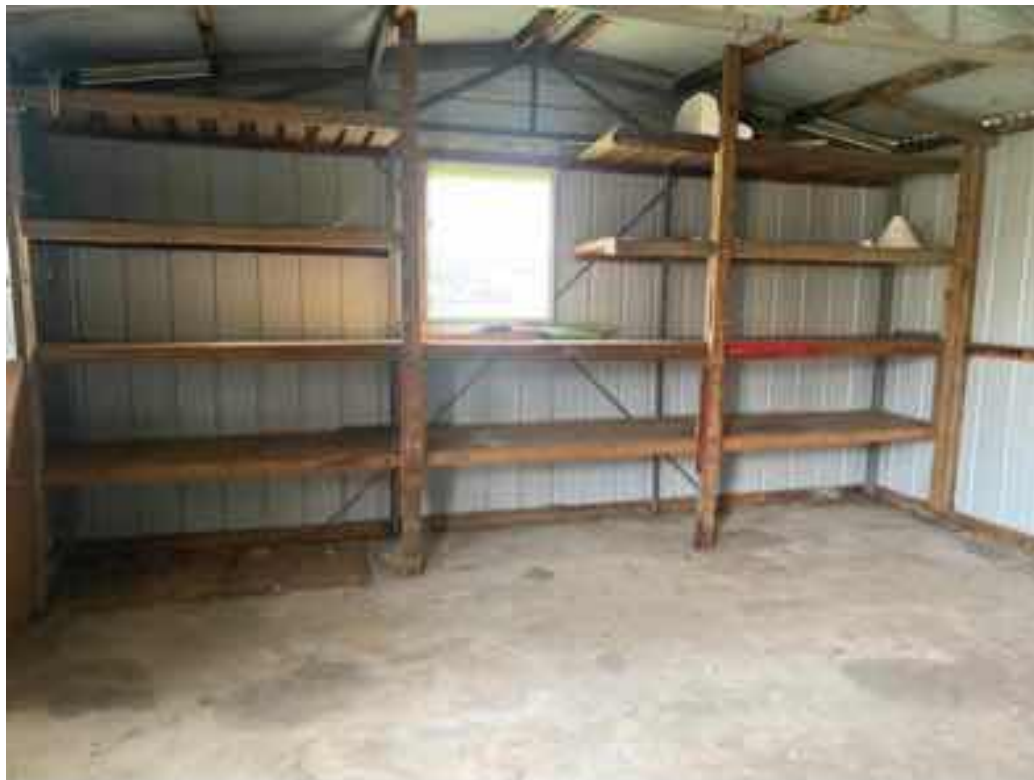
General ageing and/or denting and/or wear and/or previous wall patching and the like is evident on wall linings - Recommendations: A qualified painter should be engaged to assess and repair as required.

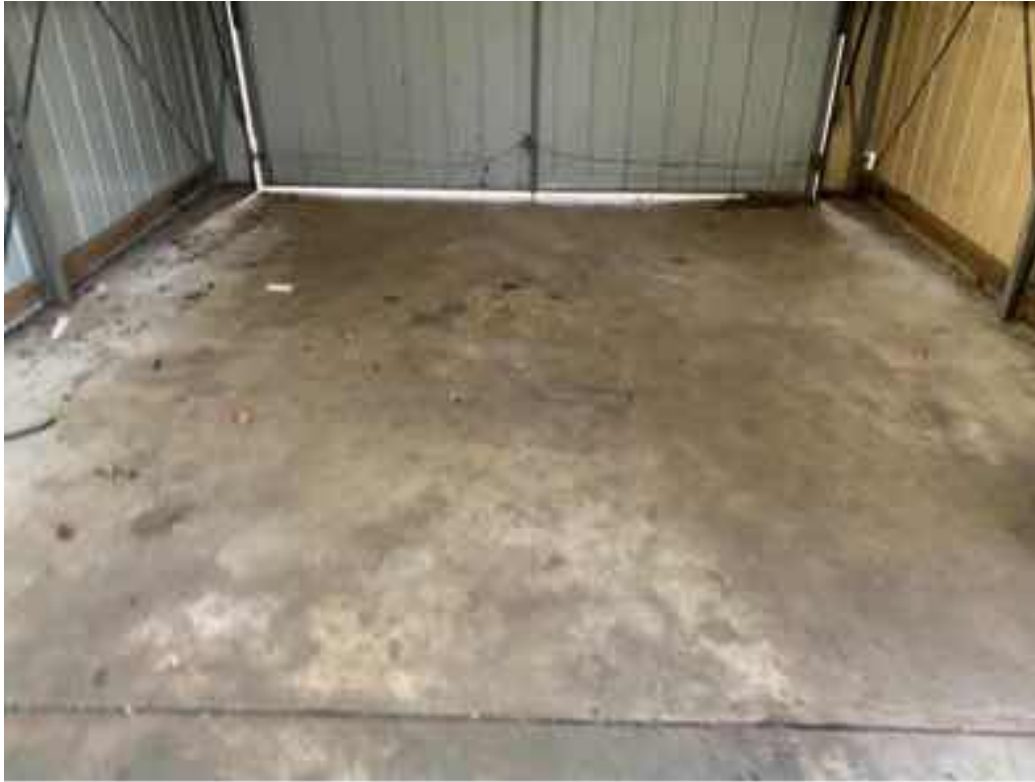
Minor hairline slab cracks - Note. Whilst these cracks appeared to be minor at the time of inspection, we strongly recommend you monitor these cracks and if worsening occurs contact a qualified concreter for further advice.

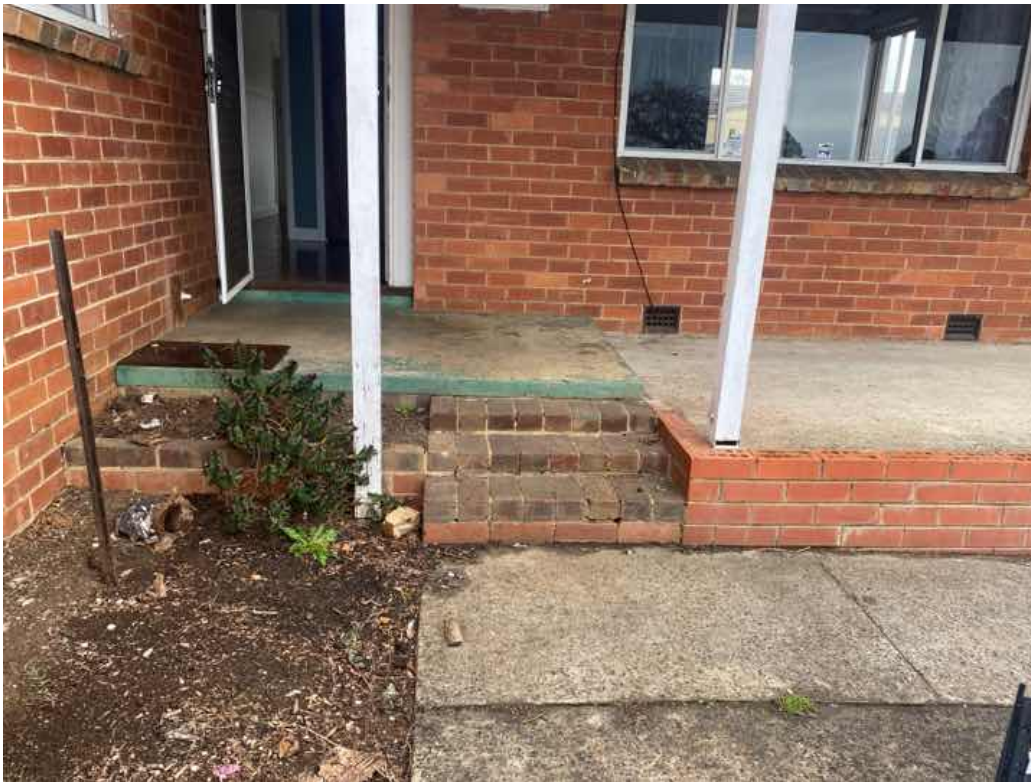
Tripping Hazard recommend rectifying to prevent harm or injury.

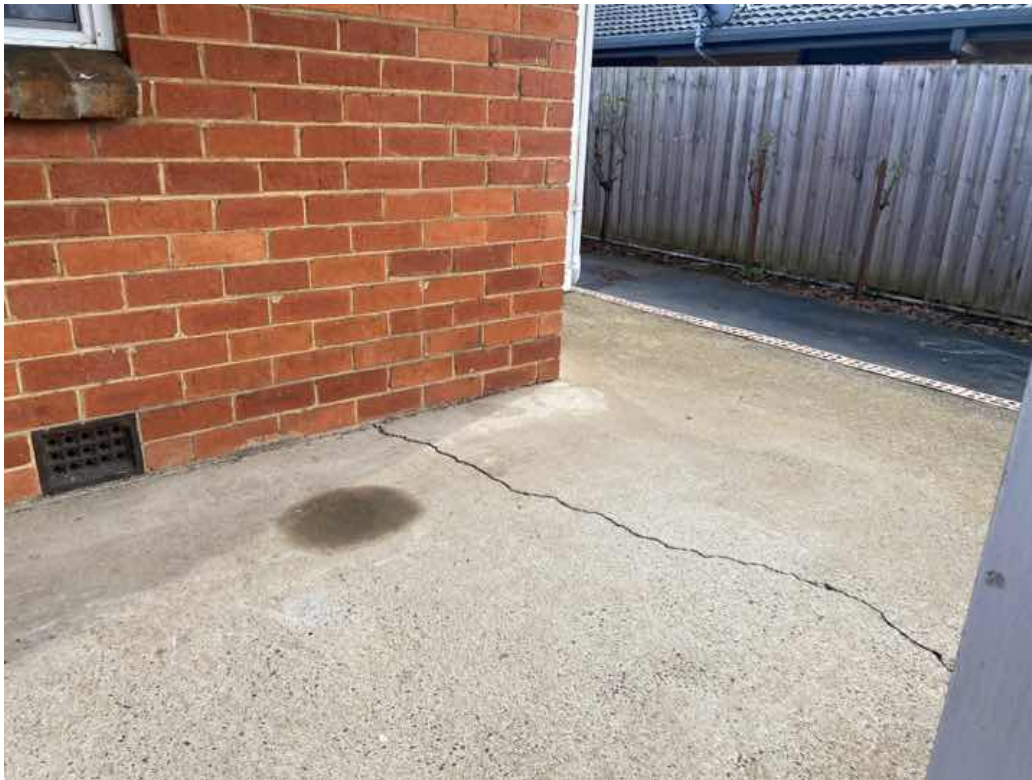
Cracked Concrete considered minor defect recommend to seek advice from Concreter.

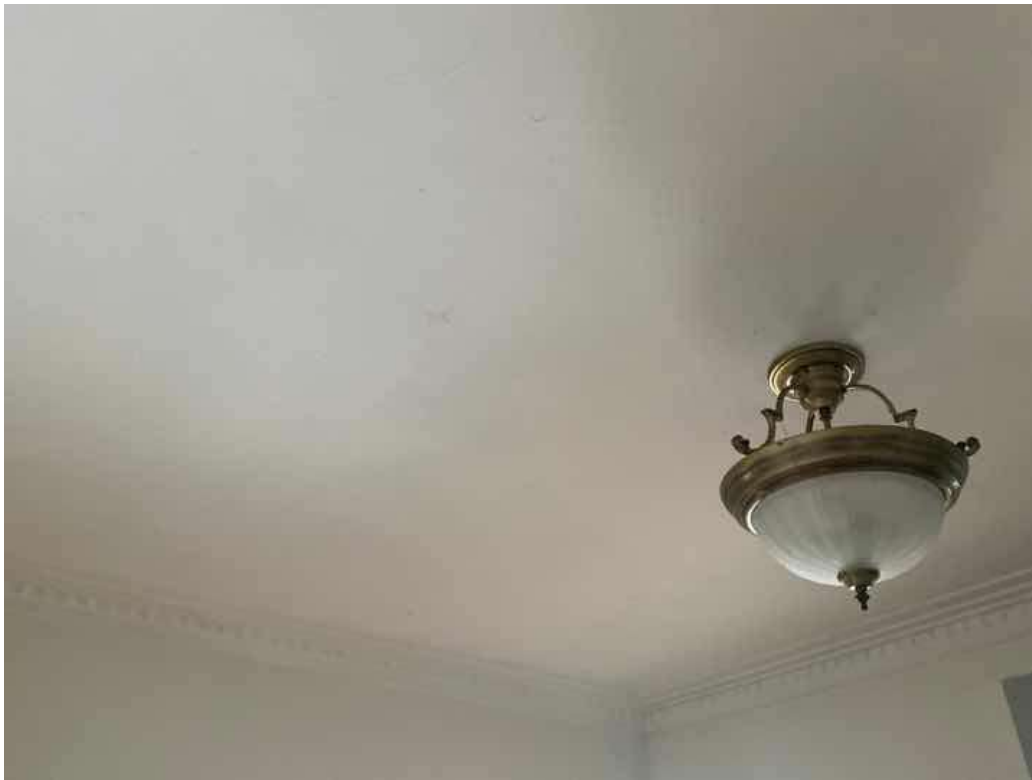
Ceiling paint flake/deterioration is evident. Recommendations: General maintenance / painting as required.

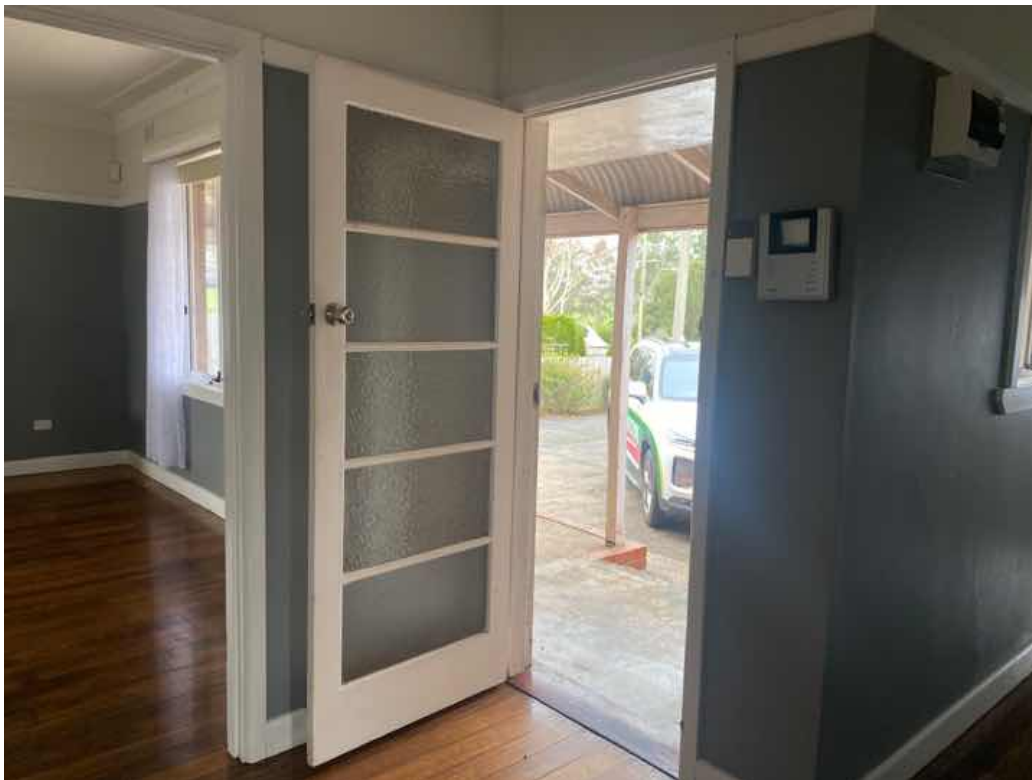
General ageing and/or denting and the like is evident on wall linings - Recommendations: A qualified painter should be engaged to assess and repair as required.

Impact damage noted. Contact a licensed plasterer for repairs.

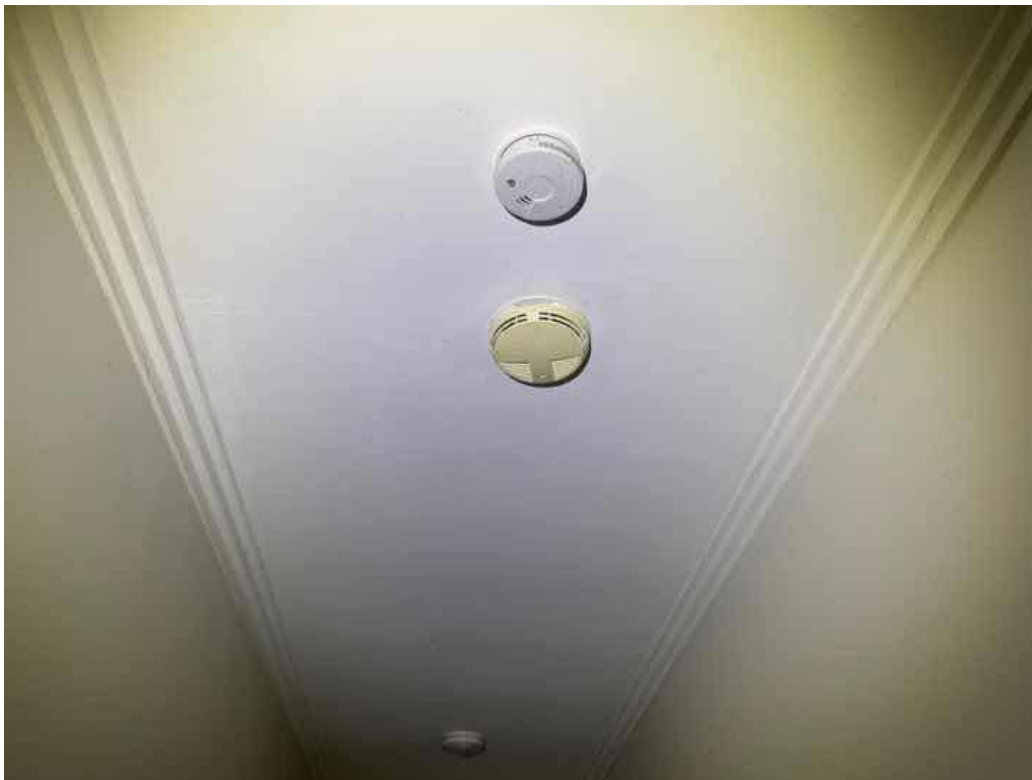
Ceiling paint flake/deterioration is evident. Recommendations: General maintenance / painting as required.

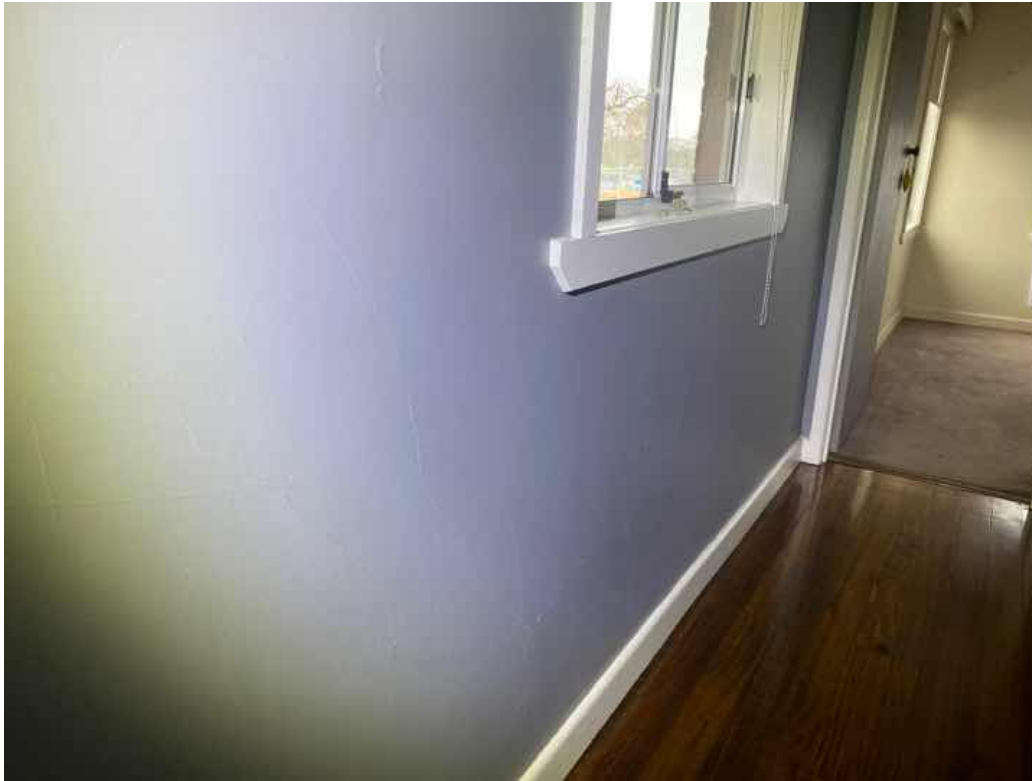
Incomplete Patch/Paint repairs noted. Call a licensed painter for repairs

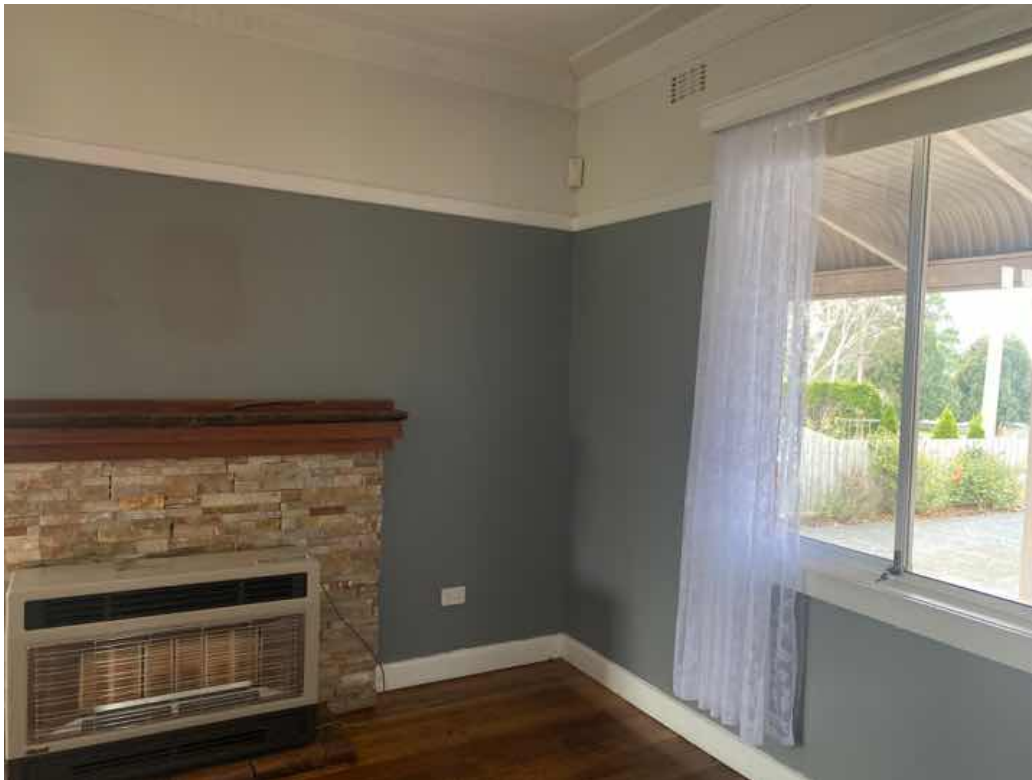
Incomplete Patch/Paint repairs noted. Call a licensed painter for repairs

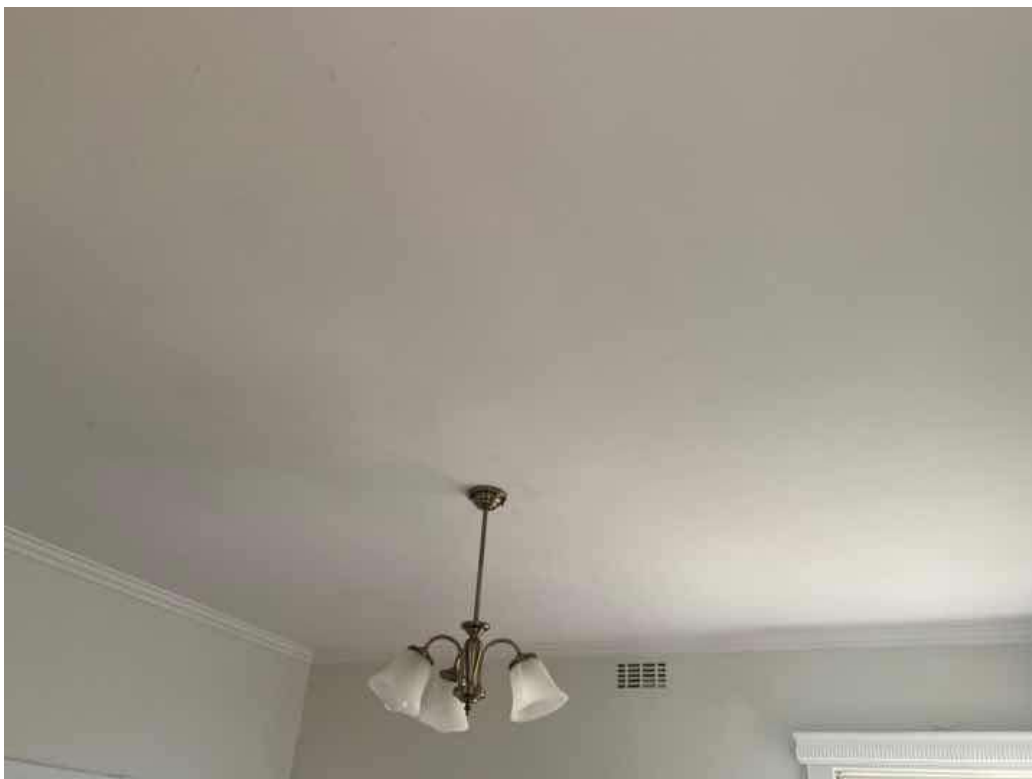
General ageing and/or denting and the like is evident on ceiling linings - Recommendations: A qualified painter should be engaged to assess and repair as required.

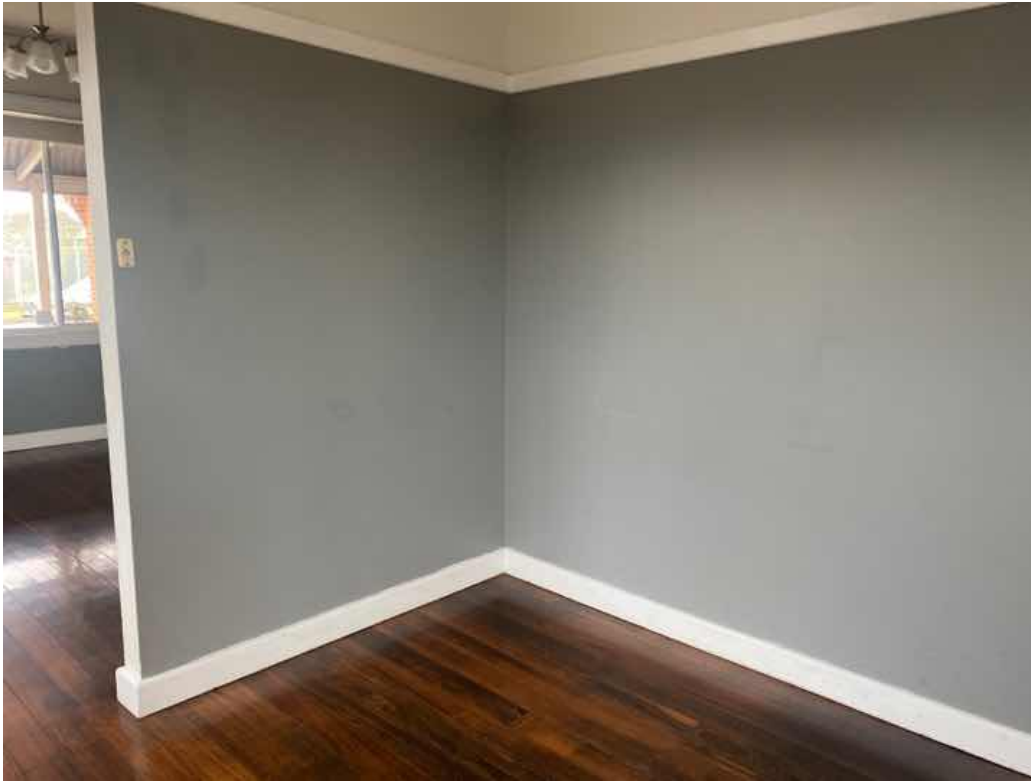
Impact damage noted. Contact a licensed plasterer for repairs.

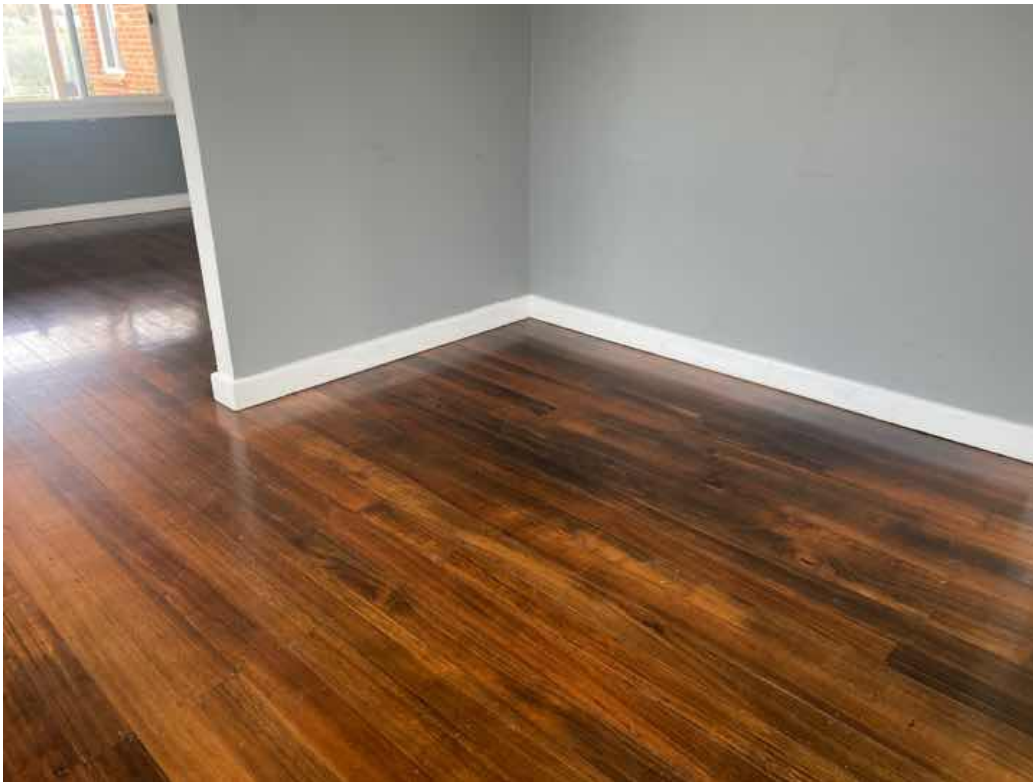
Wear & Tear is visible to flooring highly recommend a floor specialist to advise on care and maintenance to flooring for future.

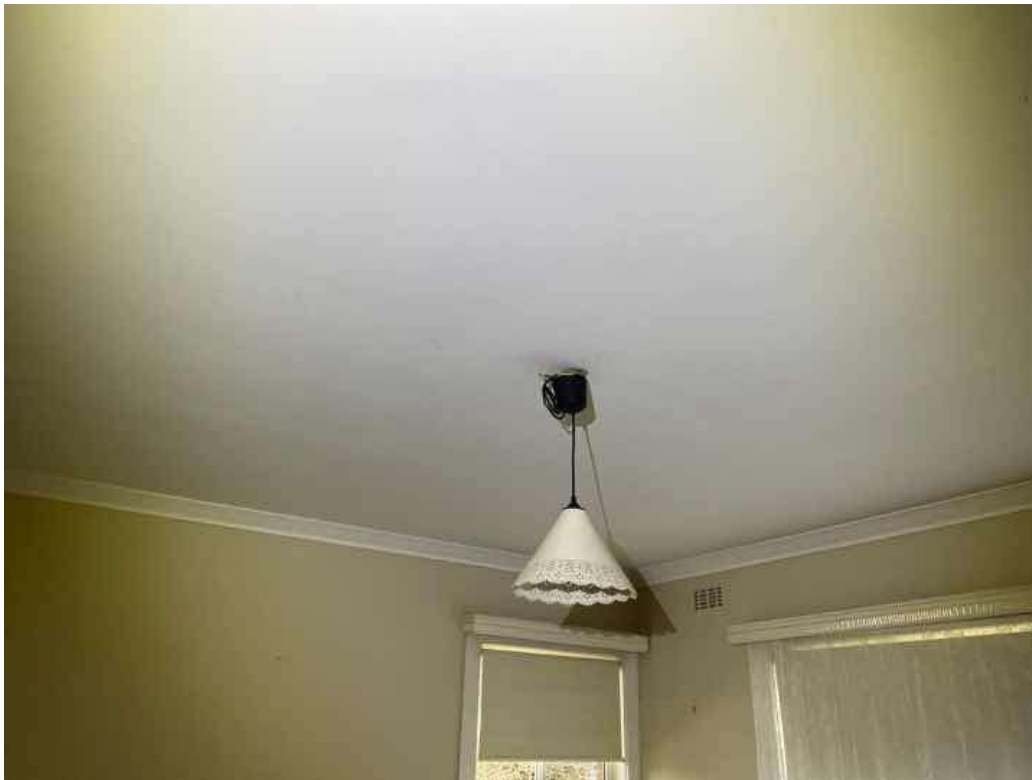
Ceiling paint flake/deterioration is evident. Recommendations: General maintenance / painting as required.

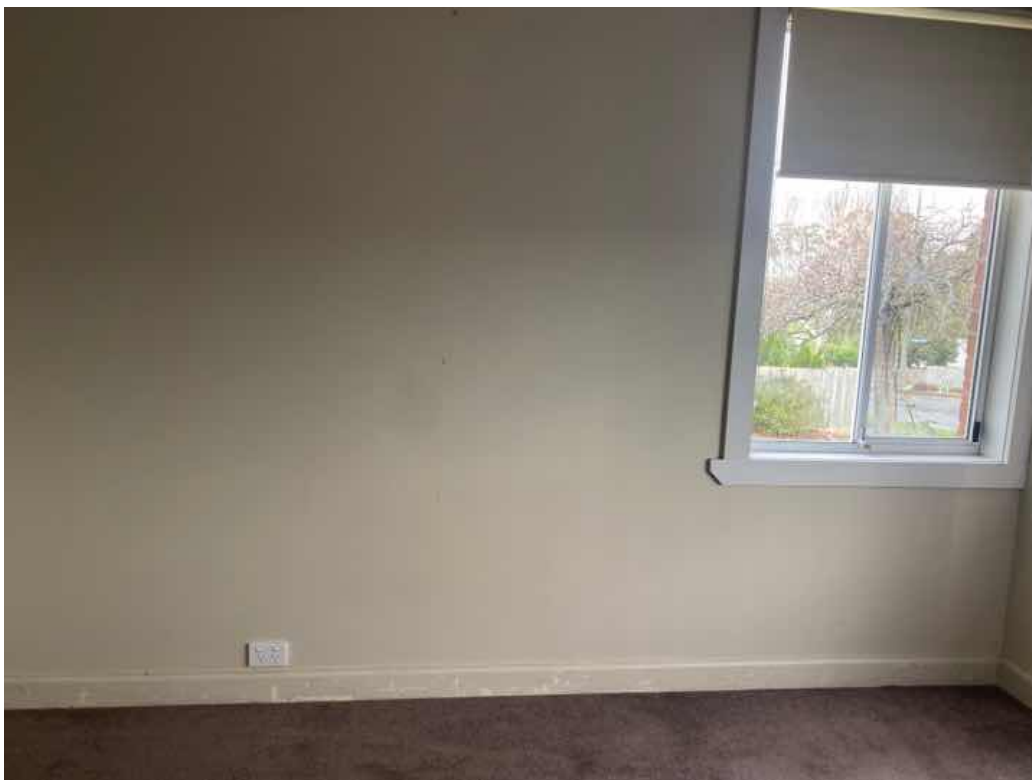
Impact damage noted. Contact a licensed plasterer for repairs.

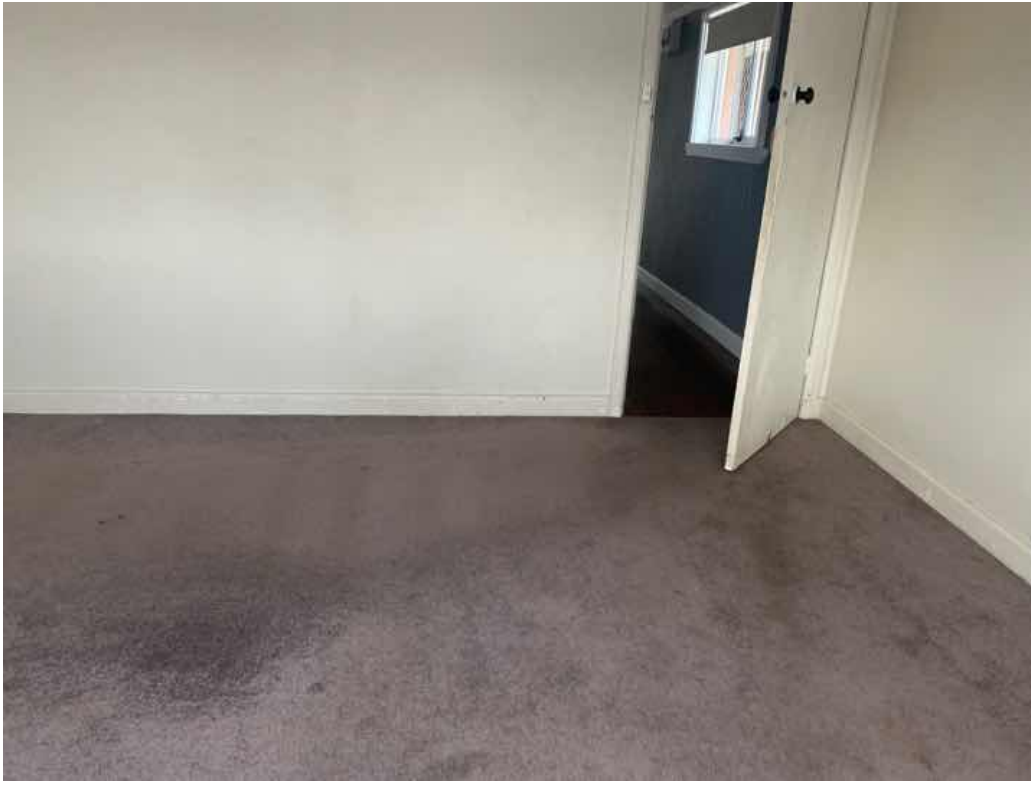
Stains observed - Recommendations: Steam cleaning may rectify stained areas but they appear entrenched.

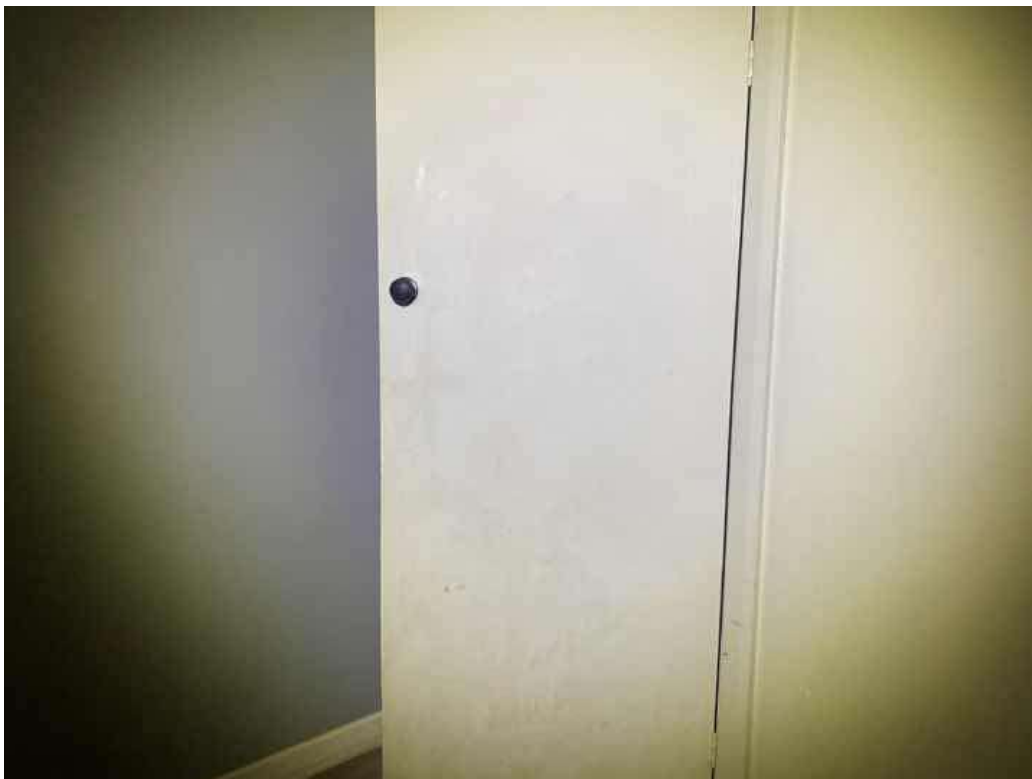
Impact damage observed. Repairs / Replacement recommended

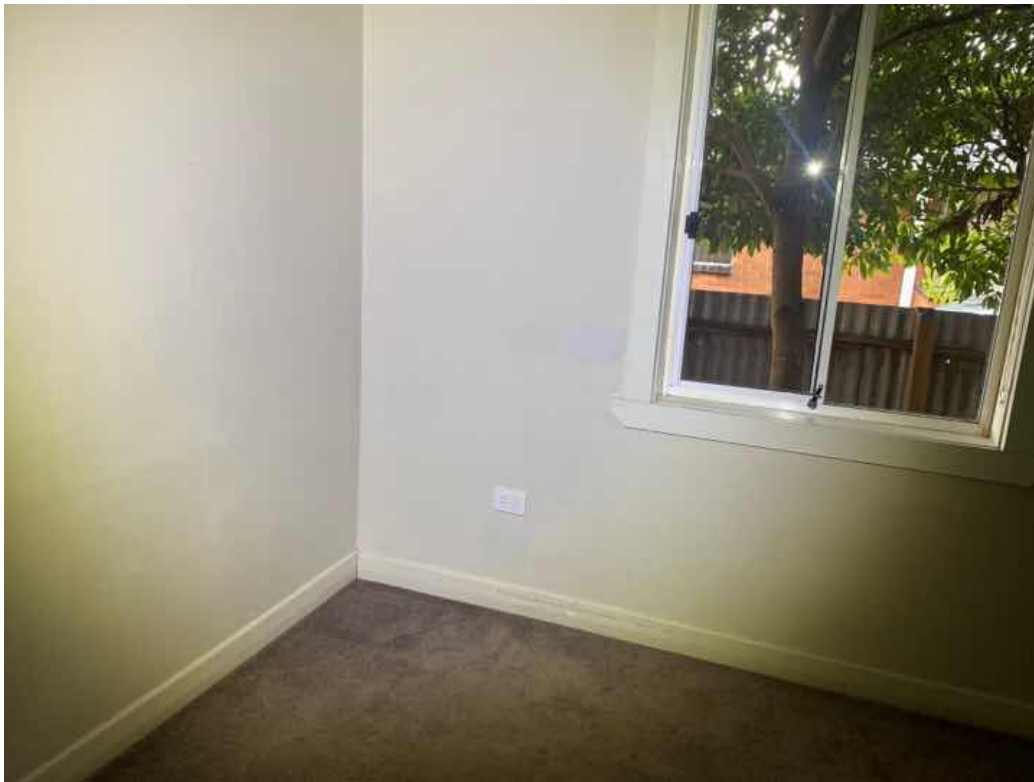
Incomplete Patch/Paint repairs noted. Call a licensed painter for repairs

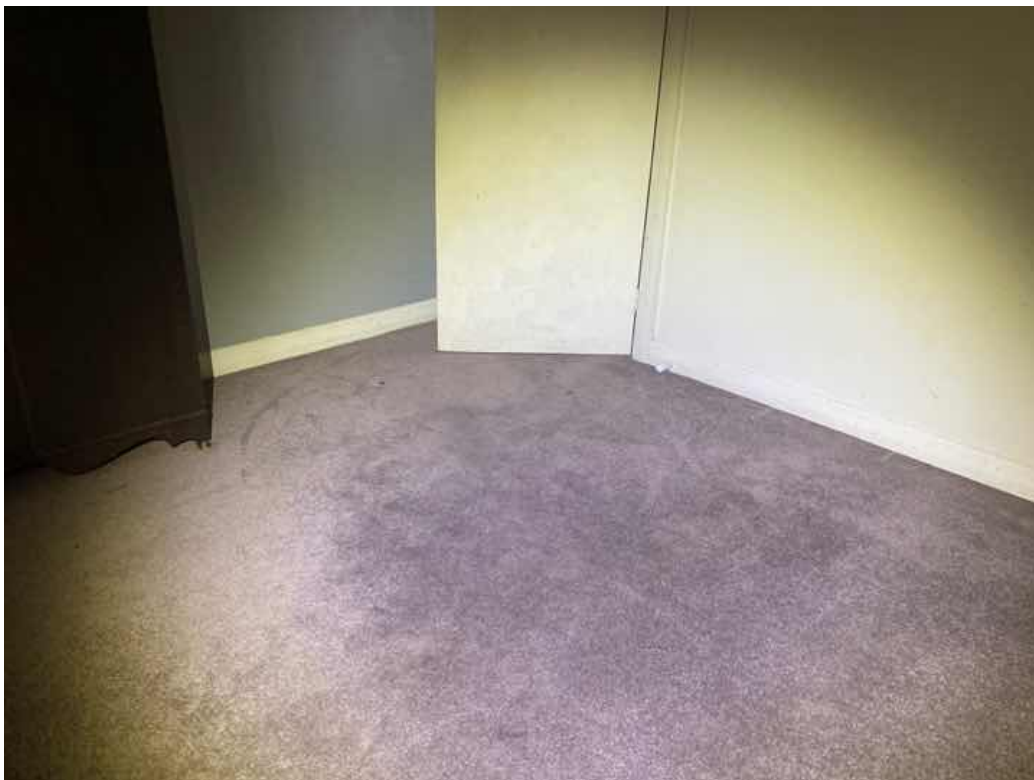
Squeaky floor boards noted. Re-fixing the floor boards may fix this issue.
