**Home Inspections For A Better Peace Of Mind.**

**123 Homebuyer Road, Homebuyers Town, Victoria, 3000**

Report/Agreement #              Combined Building & Timber Pest Inspection Report  
 Inspection Date:                  02 Jan 2023  
 Inspection Time:                  07:00

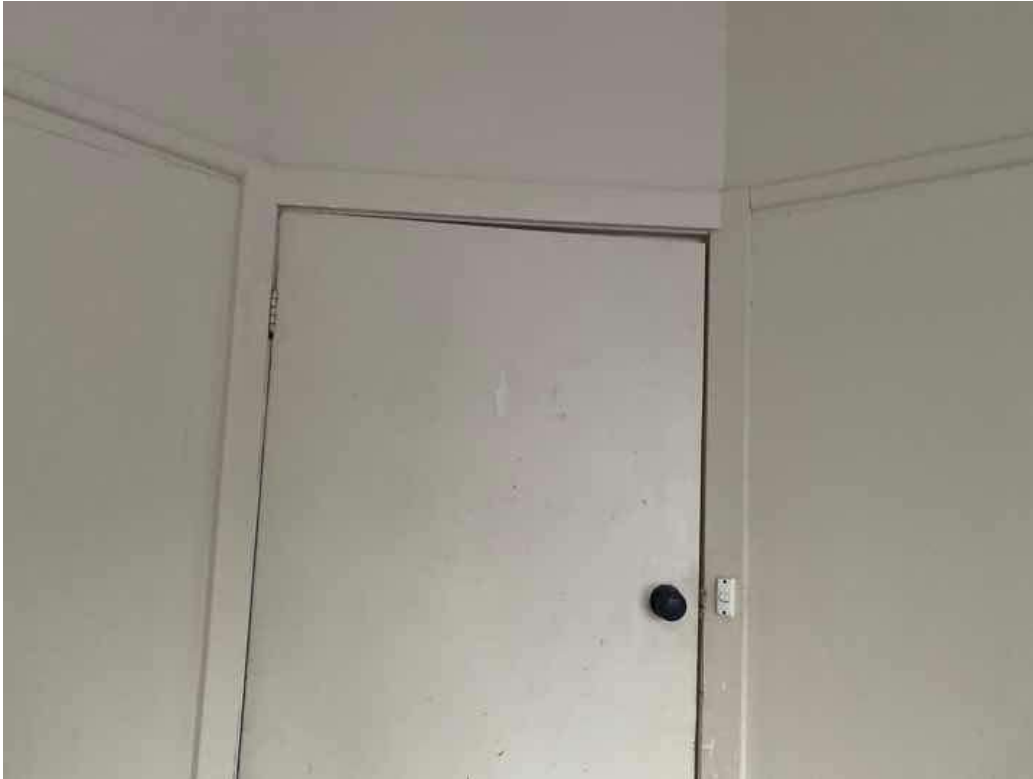
Impact damage observed. Repairs / Replacement recommended

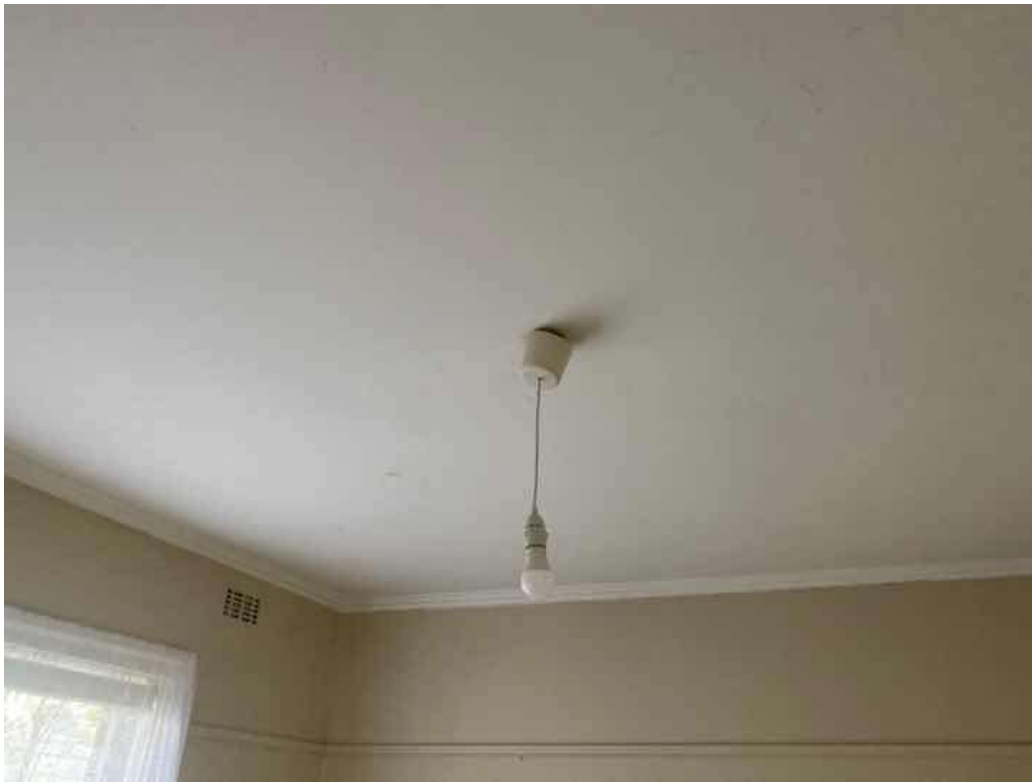
Ceiling stains - No moisture readings obtained. Recommendations: These may have been repaired, however, you will need to monitor after a prolonged period of rainfall - If leaking persists, a qualified plumber should be engaged for advice and recommendations. All water damaged plaster replaced by a qualified plasterer.

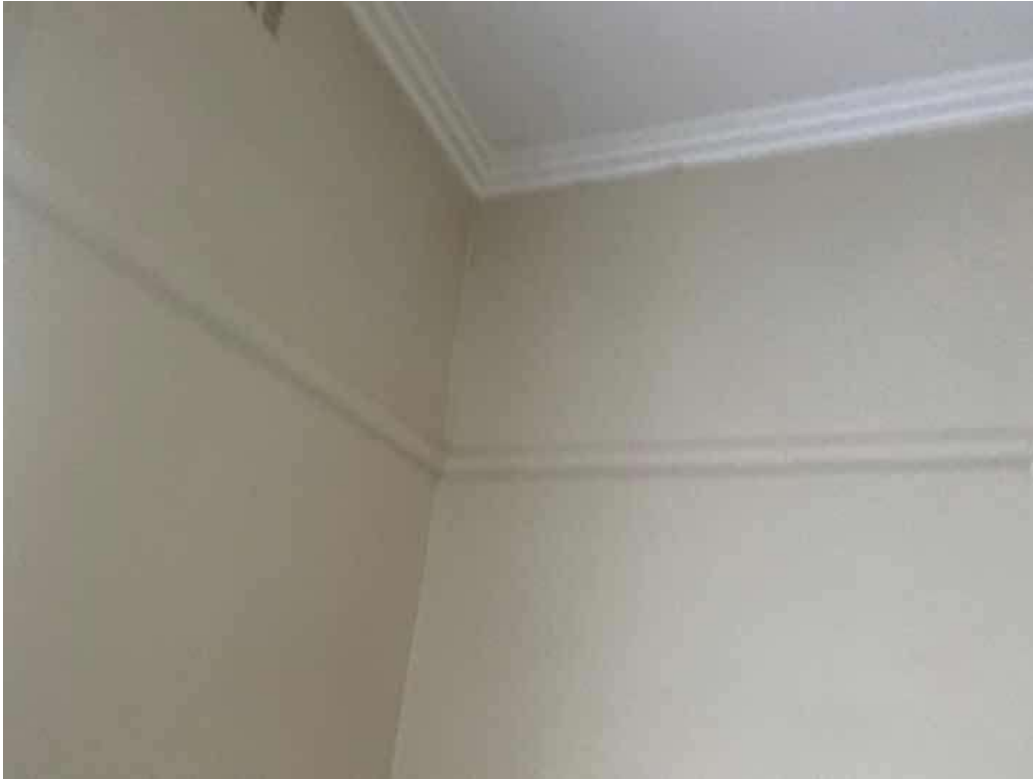
Incomplete Patch/Paint repairs noted. Call a licensed painter for repairs

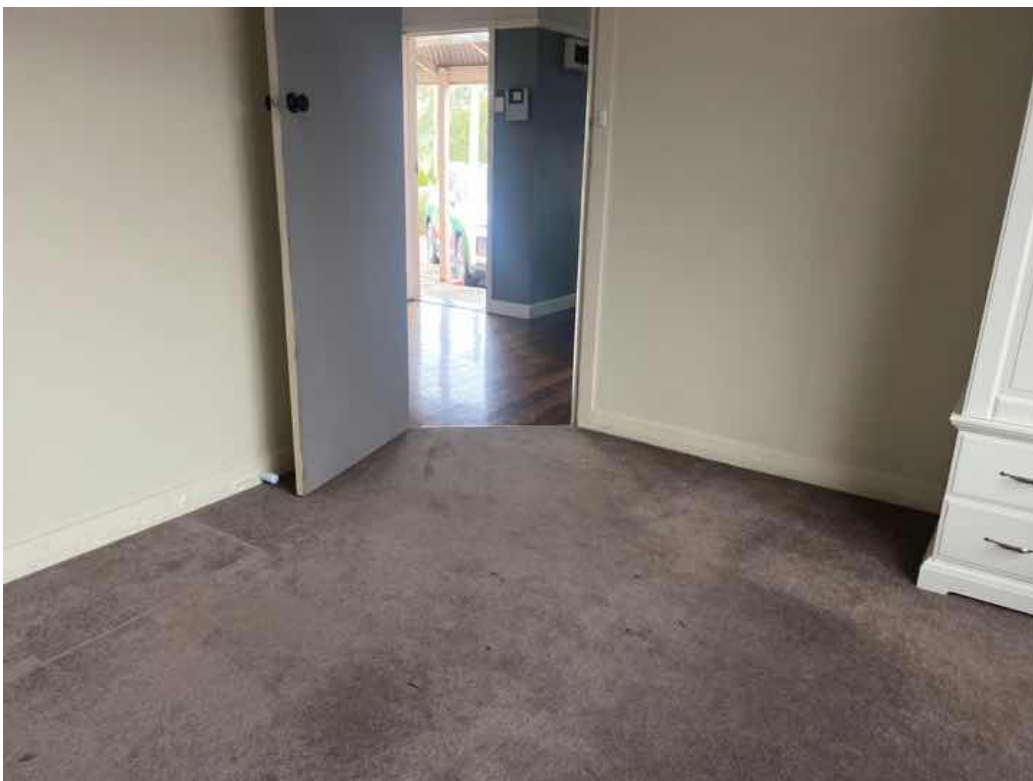
Unevenness visible in floor - Recommendations: A qualified carpenter should be engaged for advice and recommendations re levelling.

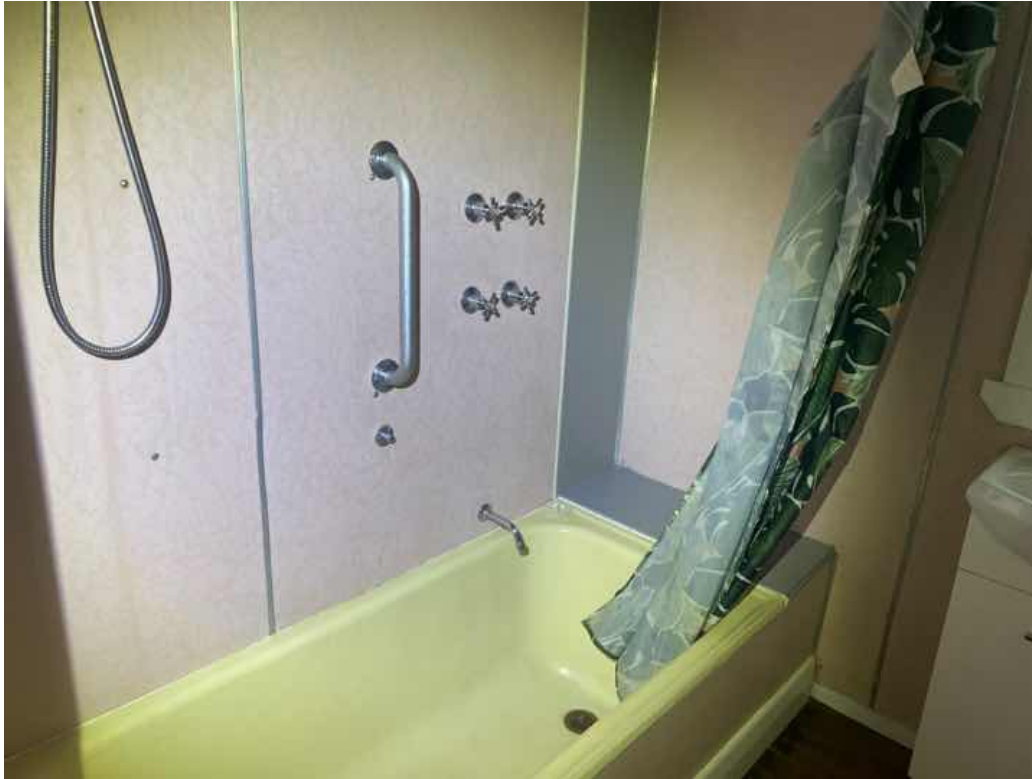
Possible Asbestos in shower recommendations are to have it tested to identify if and type of Asbestos maybe present.

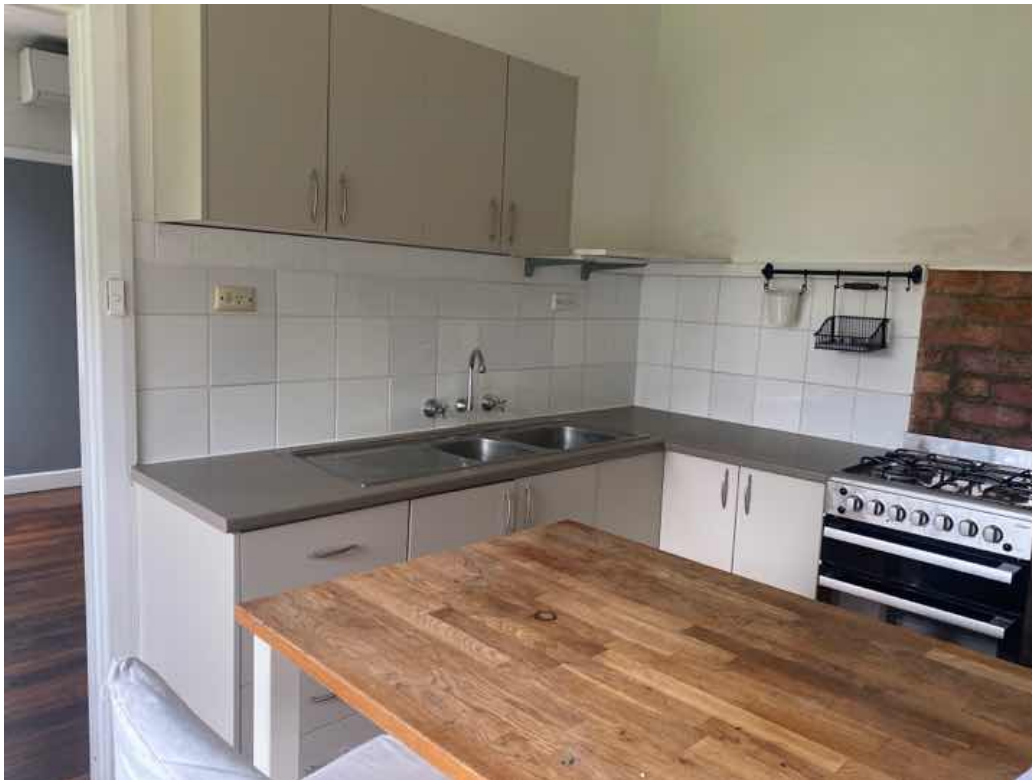
The taps are stiff to open - Recommendations: A qualified plumber should be engaged for repairs

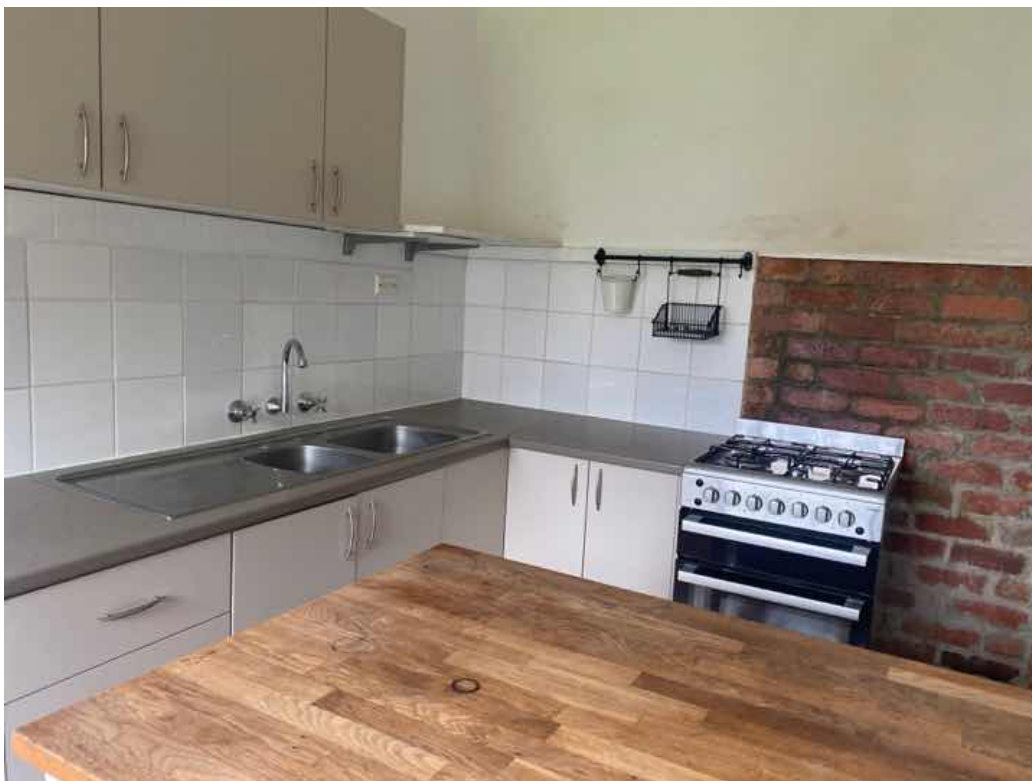
Damage was noted to the cabinets, contact a joinery company for repairs

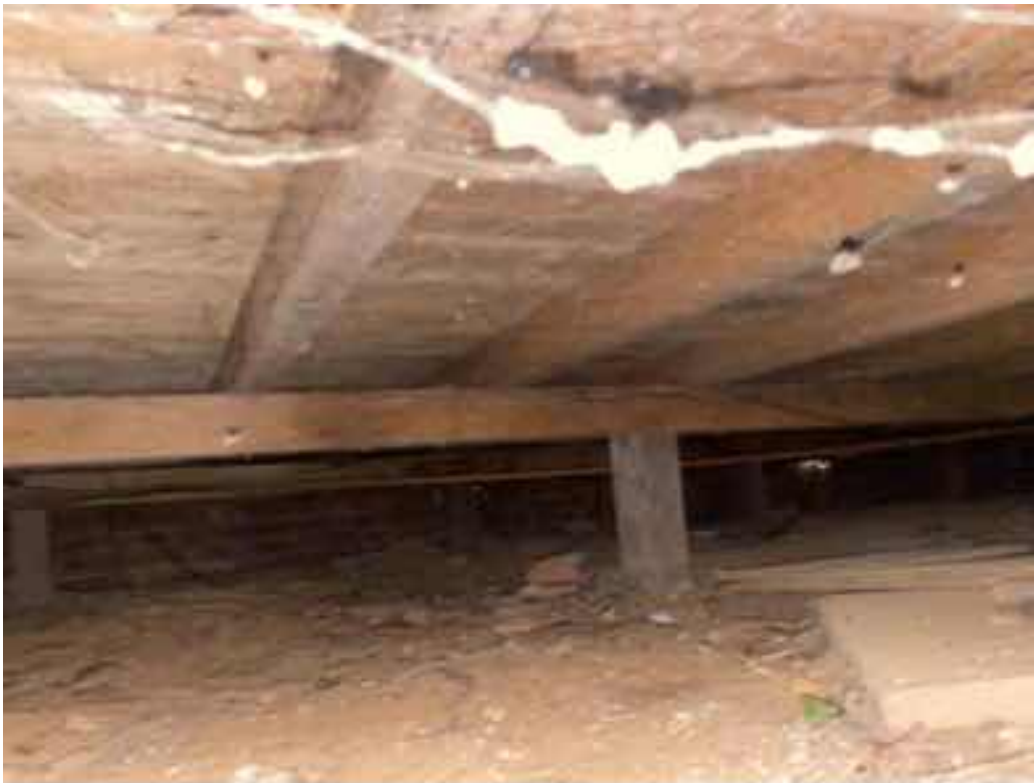
Borer damage to the floor boards was observed. Recommendations: These may require replacement. See a licensed carpenter for advice and recommendations

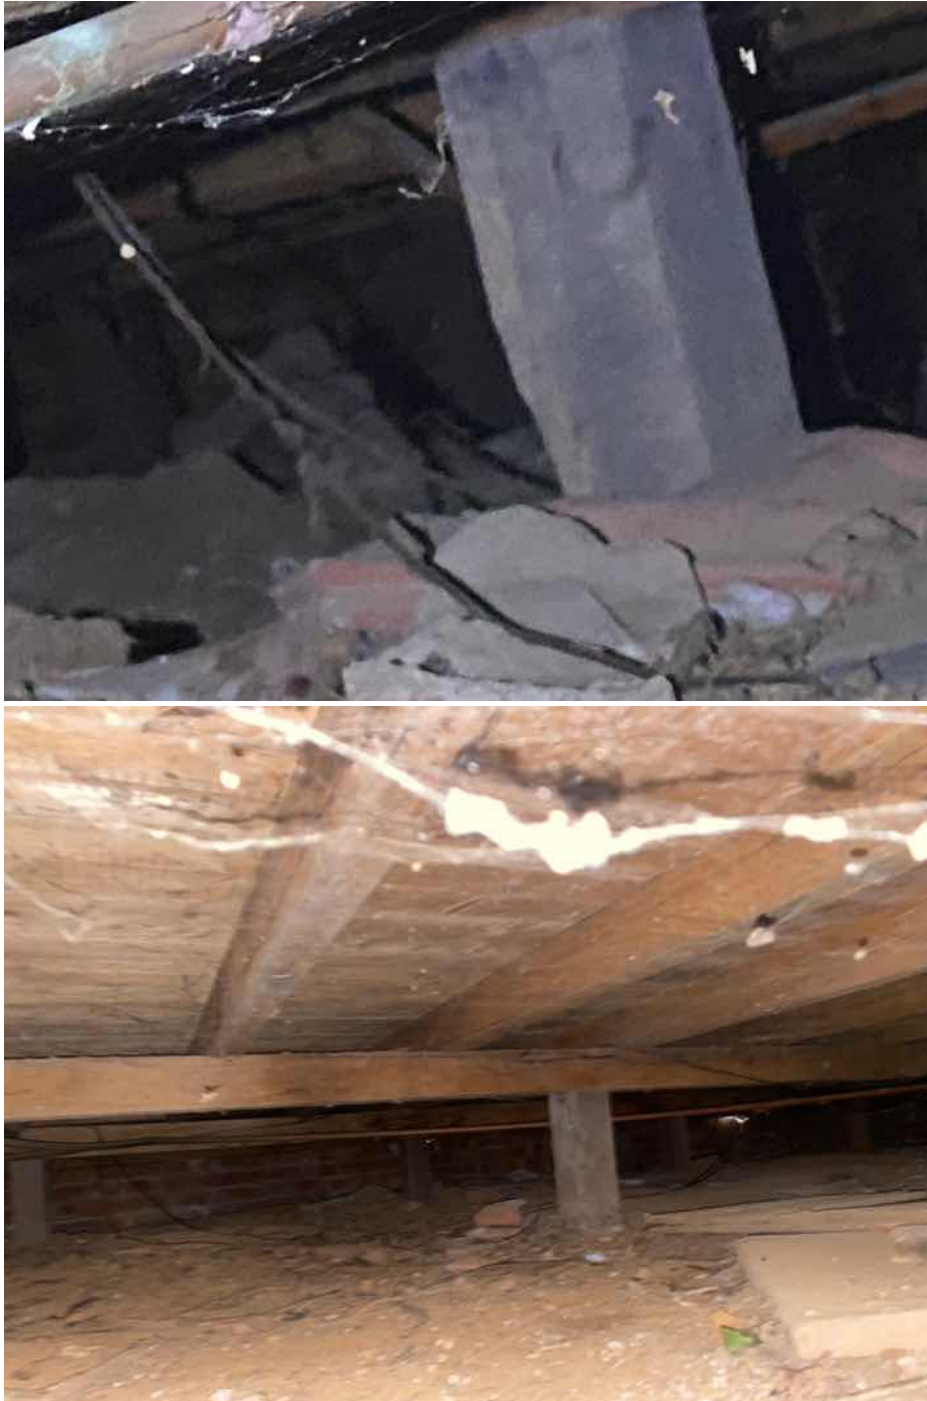
Major defect significant lose.

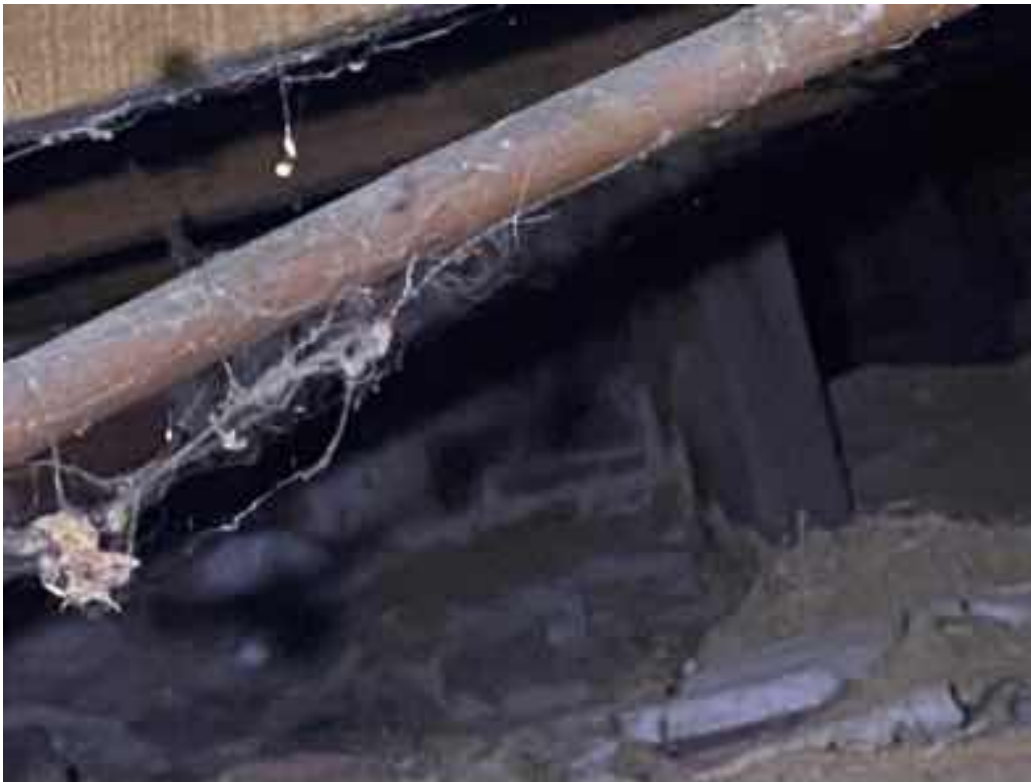
Dampness in sub floor soil. Damp sub floor soil should be avoided as it can cause fungal decay, mould and possibly footings problems. Recommendations: A qualified drainage plumber should be engaged for advice and recommendations.

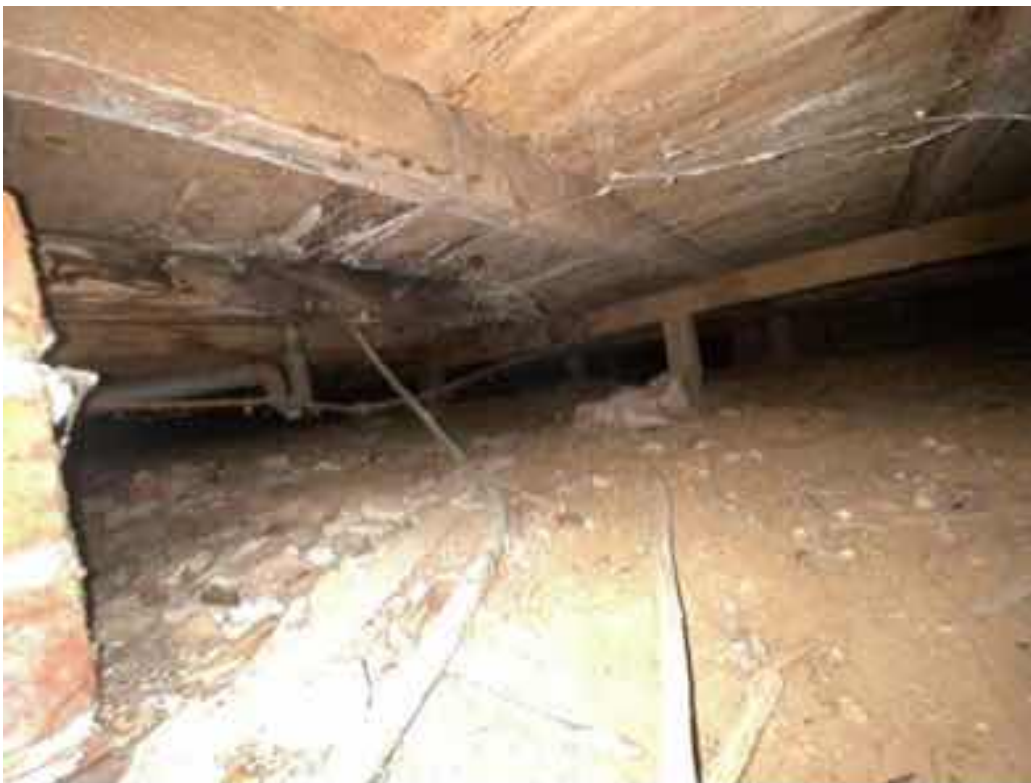
Inadequate ventilation observed. Additional vents or mechanical ventilation required. This may be conducive to timber decay and other damp related issues. Improvement to the ventilation is recommended. Contact a licensed builder for advise and rectification.

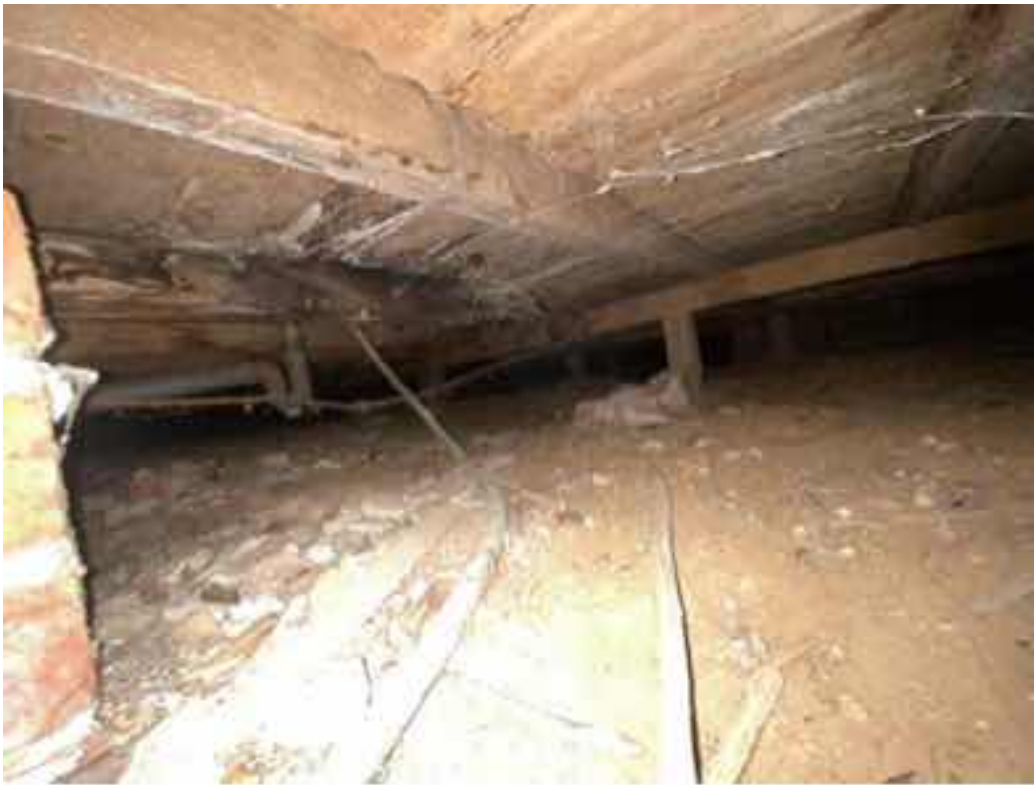
There was debris and other material in the subfloor, we recommend cleaning these to aid with ventilation and reduce the likely hood of rodents and pests.

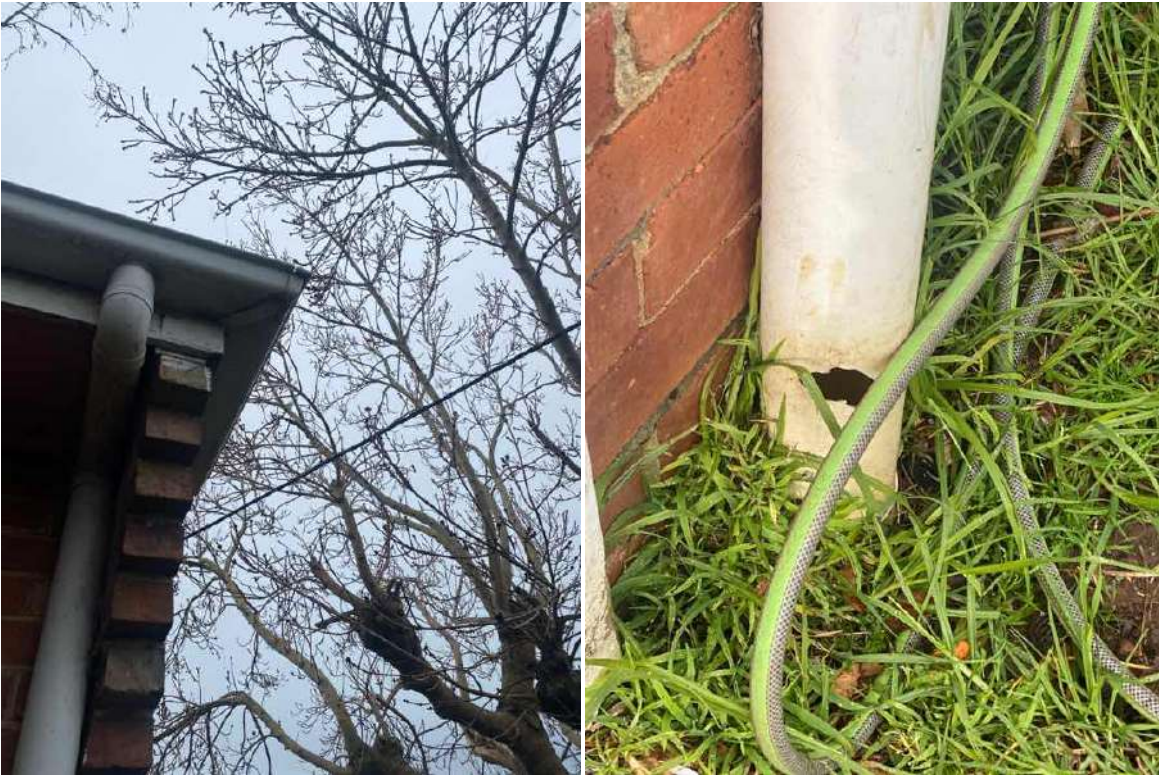
Downpipe Base is broken seek immediate advice from a licensed plumber for immediate repair.

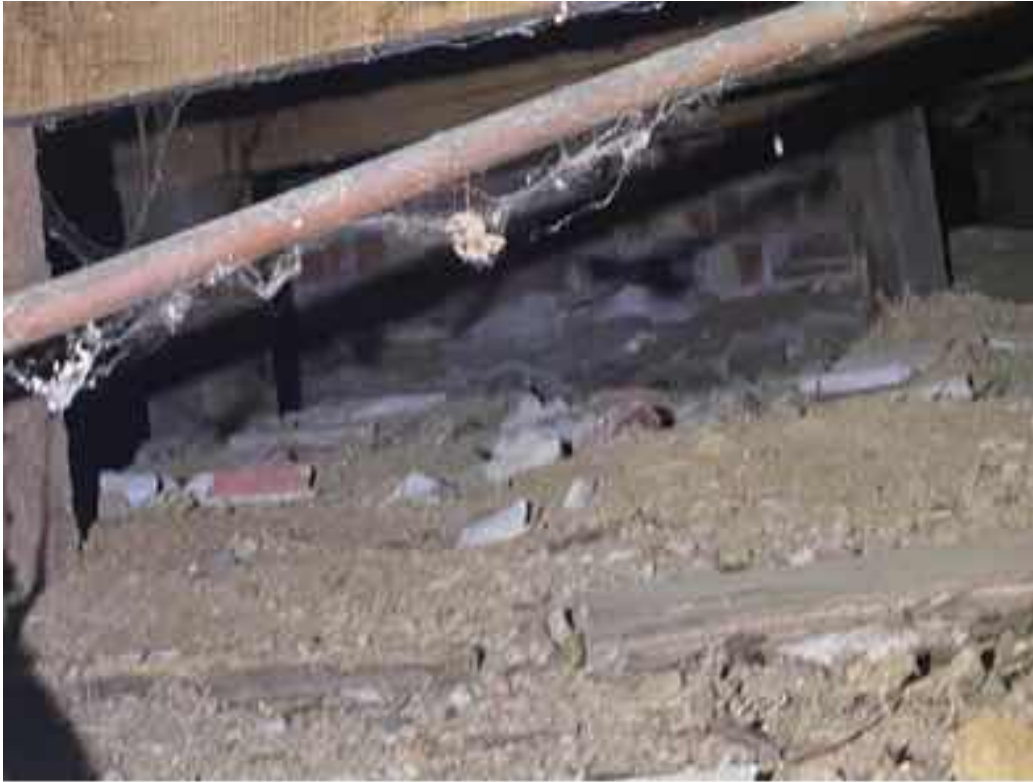
The ventilation isn't adequate in the subfloor. This needs to be improved by either clearing/exposing all air vents to enable sufficient airflow or potentially installing further vents in the external walls. This lack of good ventilation is a conducive condition for termites.

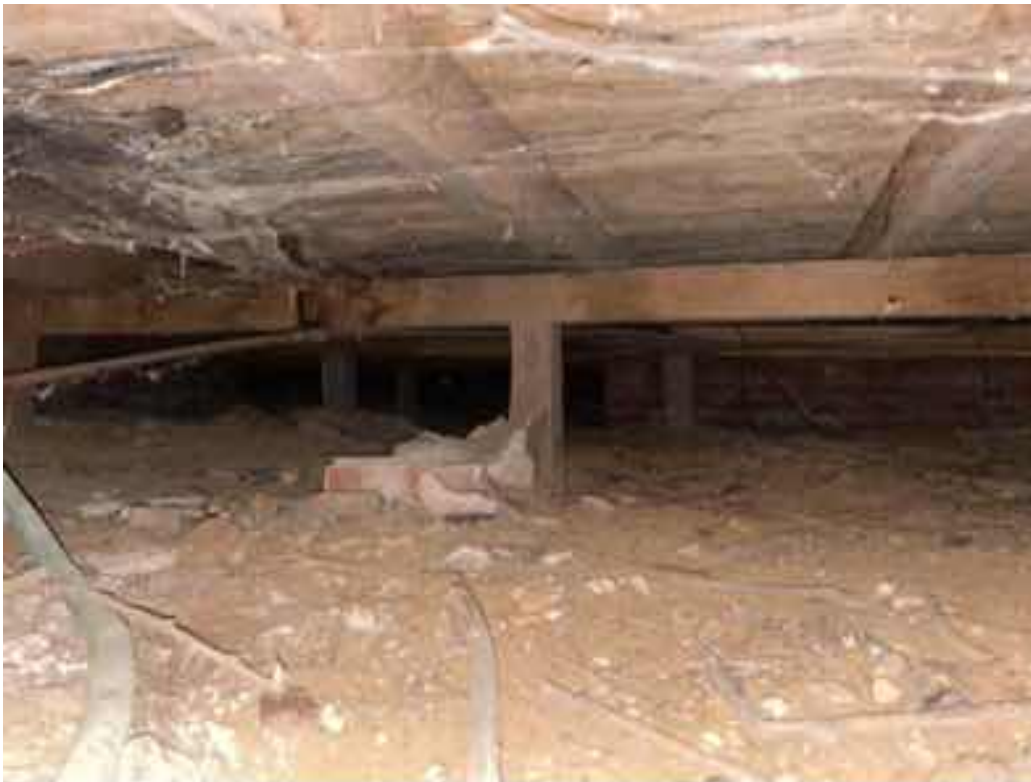
The termite shields ( ant caps ) are inadequate

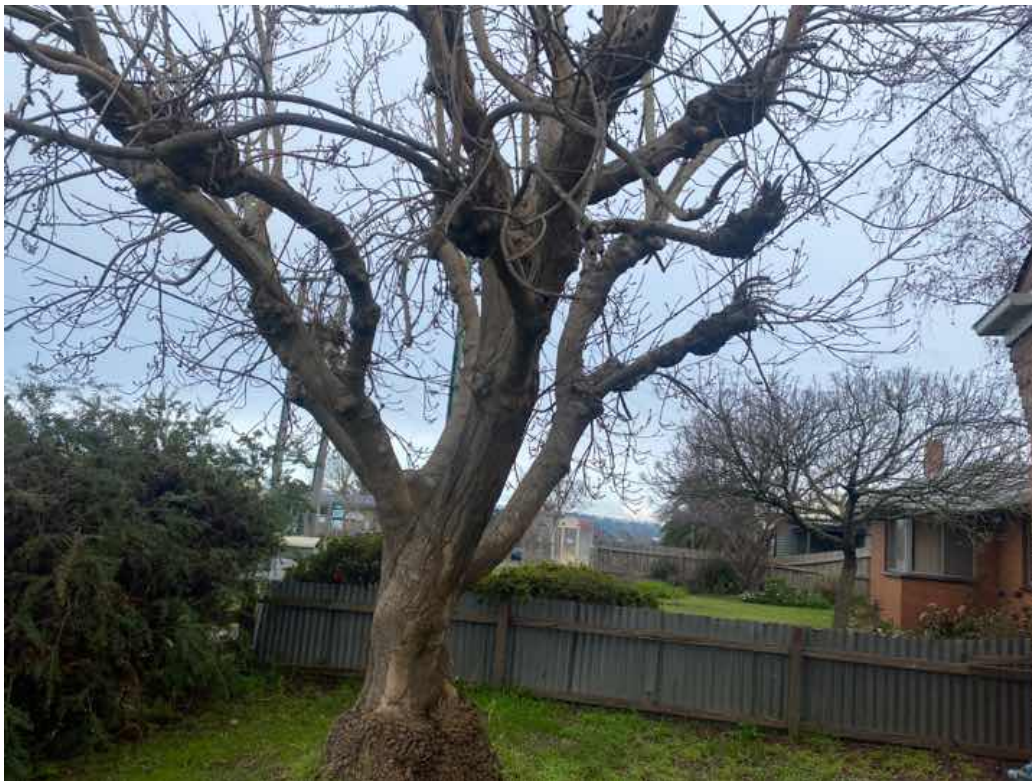
Trees are in close proximity to the dwelling and within the termite foraging area. These are a favorable influence for termite infestation and i recommend you liaise with the neighbours to have regularly checked and if in your site, organise regular inspections for termite infestation.
