**Home Inspections For A Better Peace Of Mind.**

**123 Homebuyer Road, Homebuyers Town, Victoria, 3000**

Report/Agreement #              Combined Building & Timber Pest Inspection Report  
 Inspection Date:                  02 Jan 2023  
 Inspection Time:                  07:00

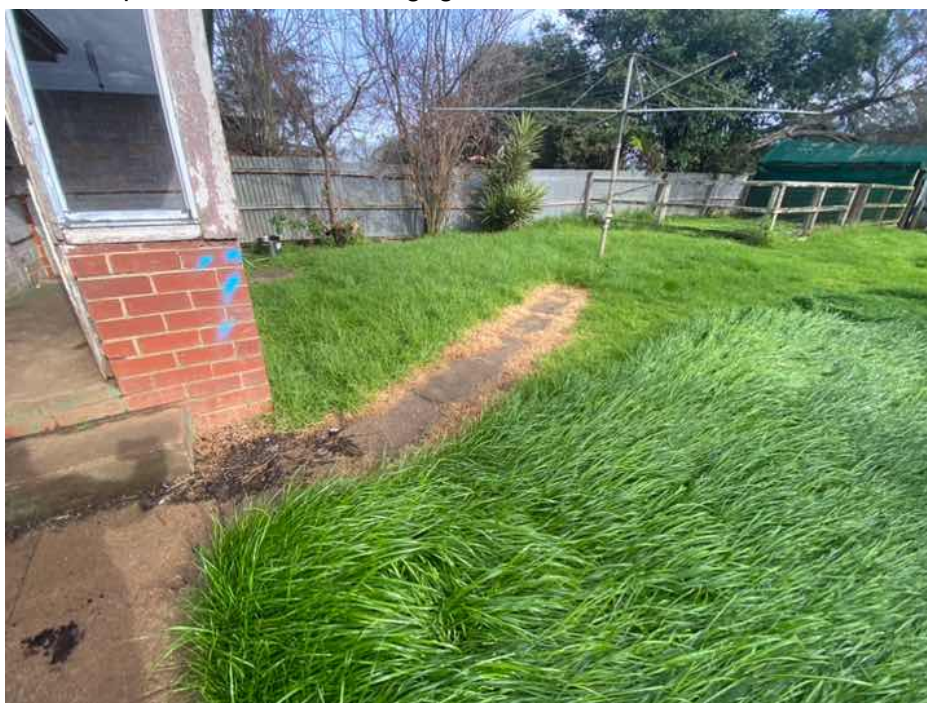
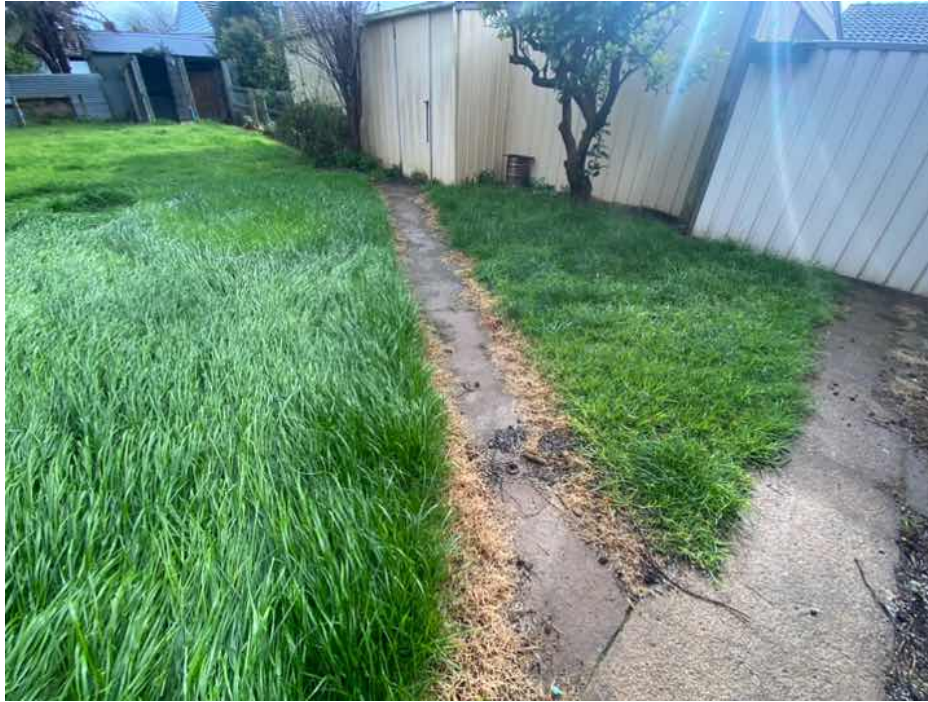
Surface raised and settled in some areas. This can cause water ponding. Relaying recommended.

There is evidence around the home paths that ponding near walls has occurred. Recommendations: A qualified landscaping contractor or a plumber should be engaged for advice and recommendations.

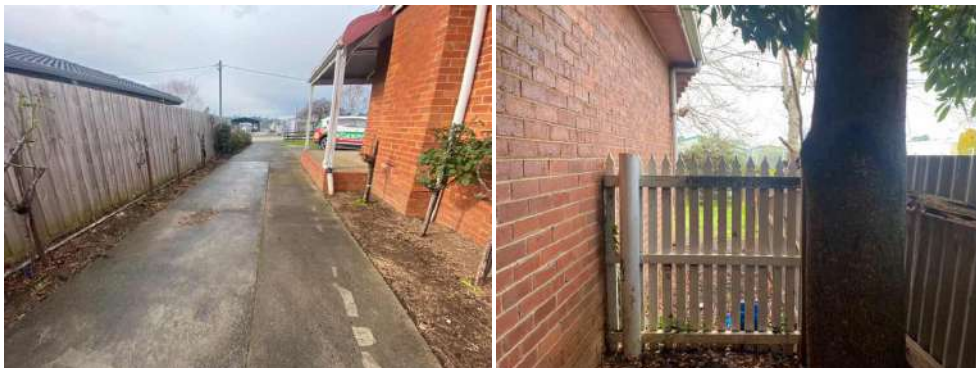
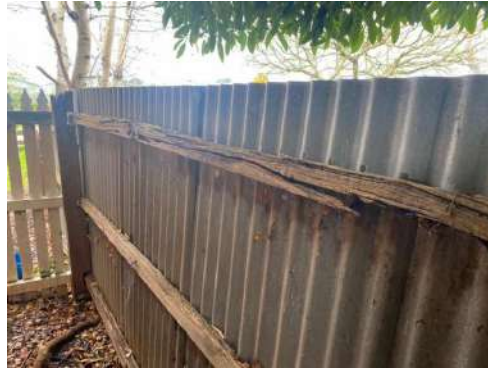
Fence is leaning seek advice from a fence contractor.

Fungal decay is visible have a fence contractor to replace decaying fence.

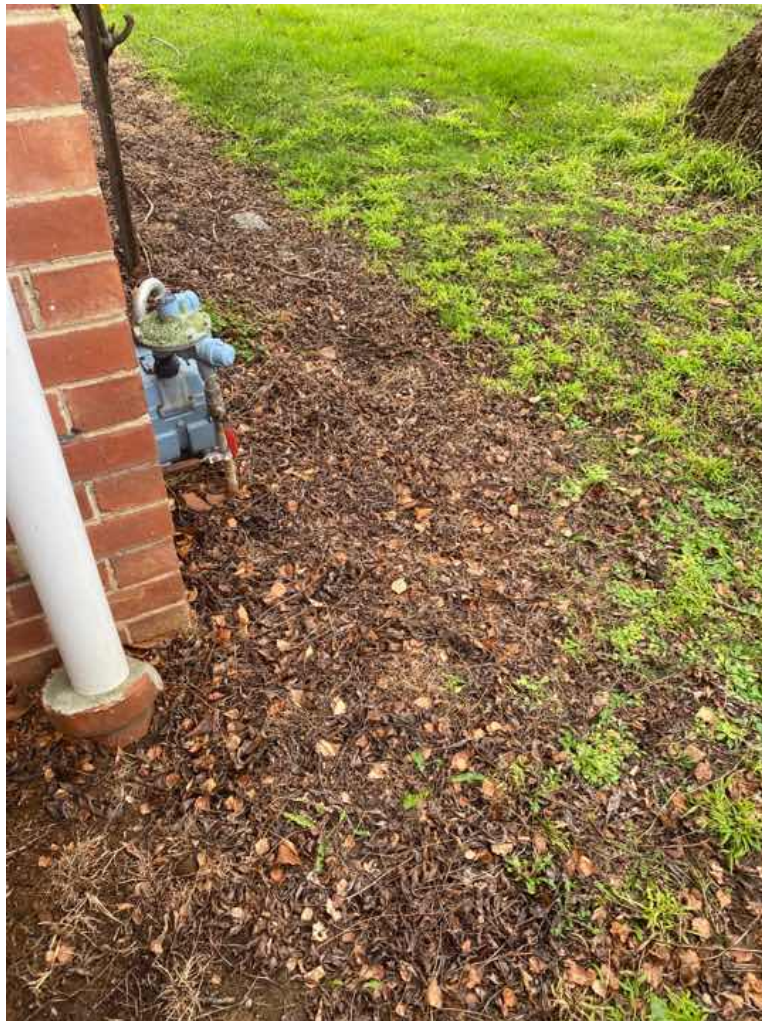
There is evidence around the home paths that ponding near walls has occurred. Recommendations: A qualified landscaping contractor or a plumber should be engaged for advice and recommendations.

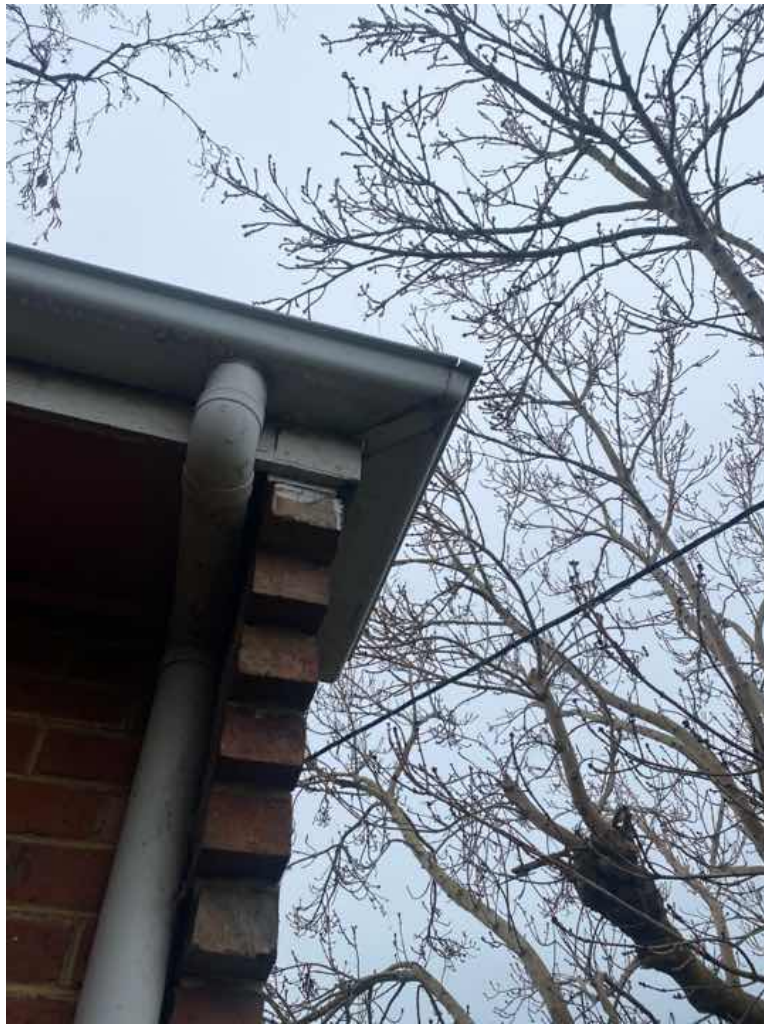
Debris evident in/around drains - Requires cleaning out.

Gutter join is leaking seek expert advice from a licensed plumber for repair.

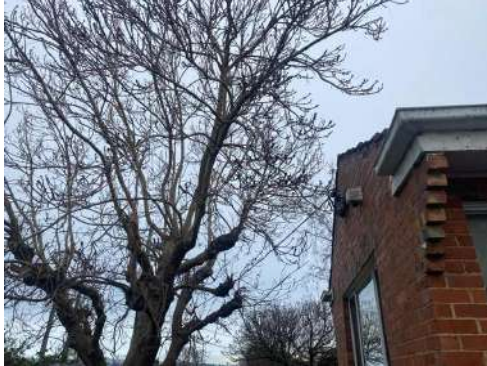
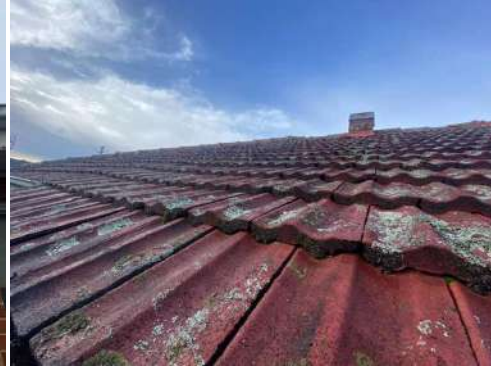
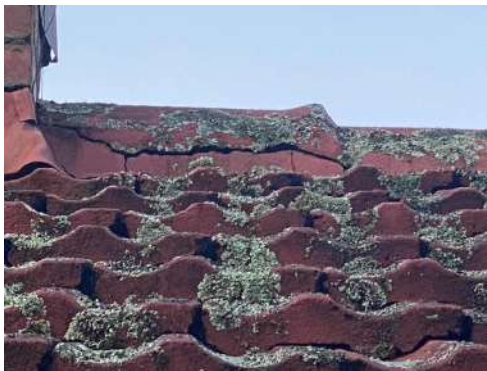
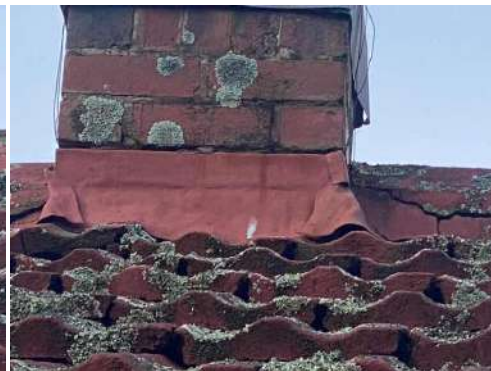
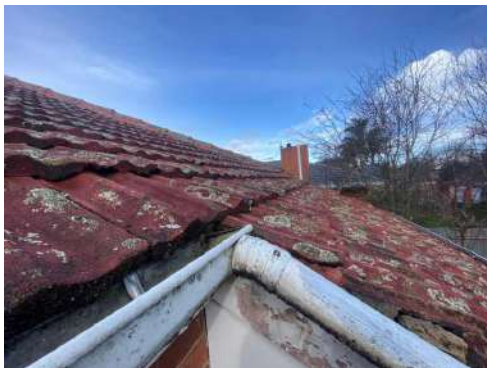
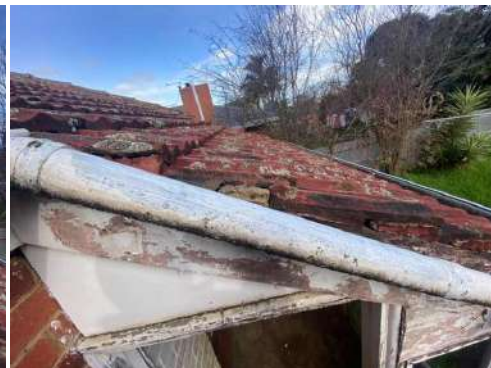
Roof valley has visible rust seek expert advice from a licensed roof plumber.

Broken Roof Tiles seek expert advice from a roof tiler.

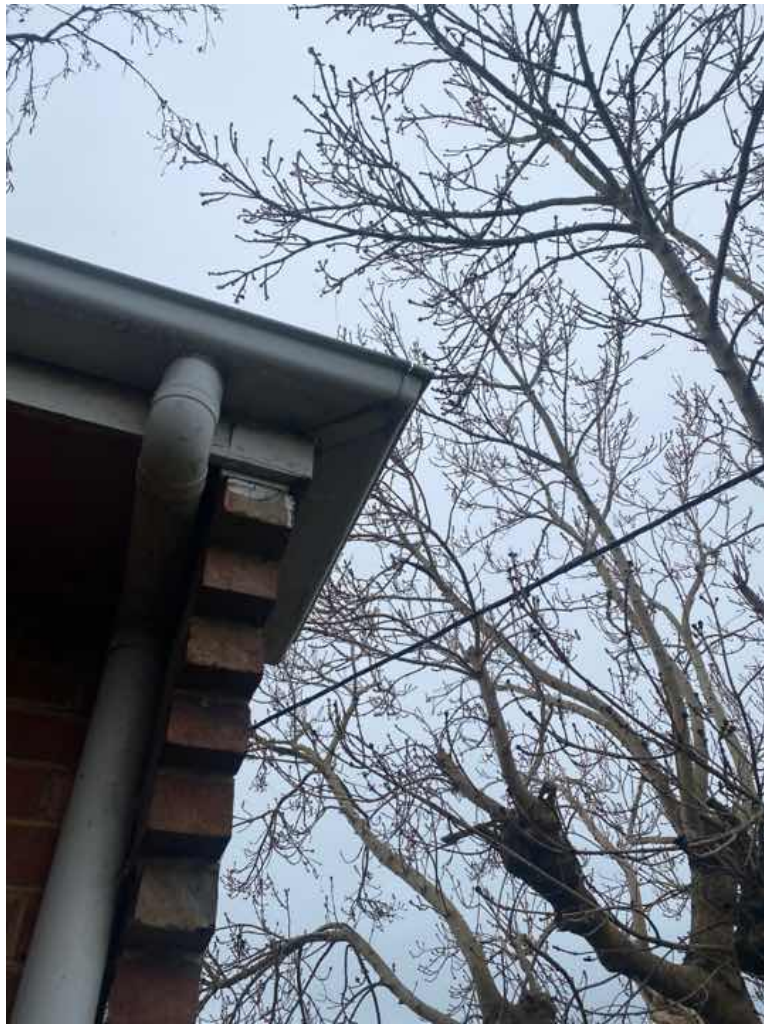
Debris in guttering areas- this requires cleaning out to prevent blocking of down pipes and leaking into eaves and fascia. Recommendations: Have gutters cleaned and assessed by a plumber for adequate fall. Also regularly clean to prevent ponding. Ponding water will contribute to rust.

There is evidence of leaking gutters. Contact a roof plumber for advice and repairs.

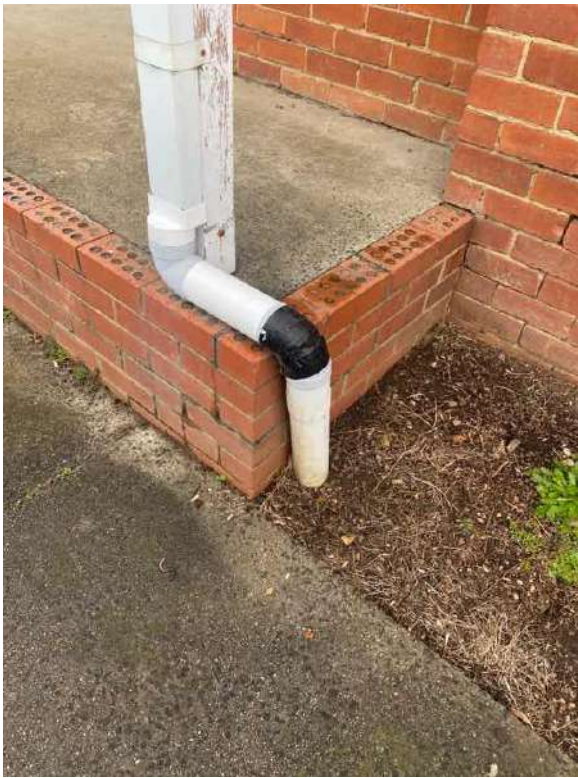
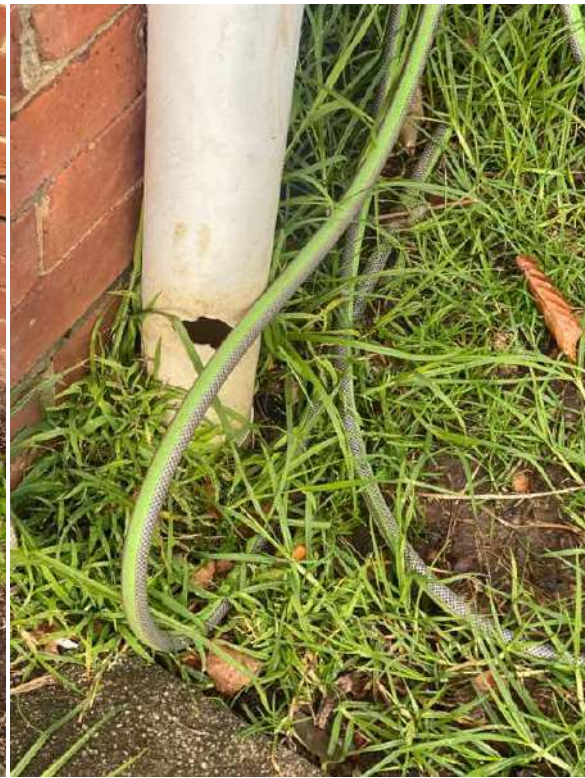
Impact damage noted to down pipe. Contact a roof plumber for replacement as required.

Repair to downpipe is visible seek expert advice from a licensed plumber.

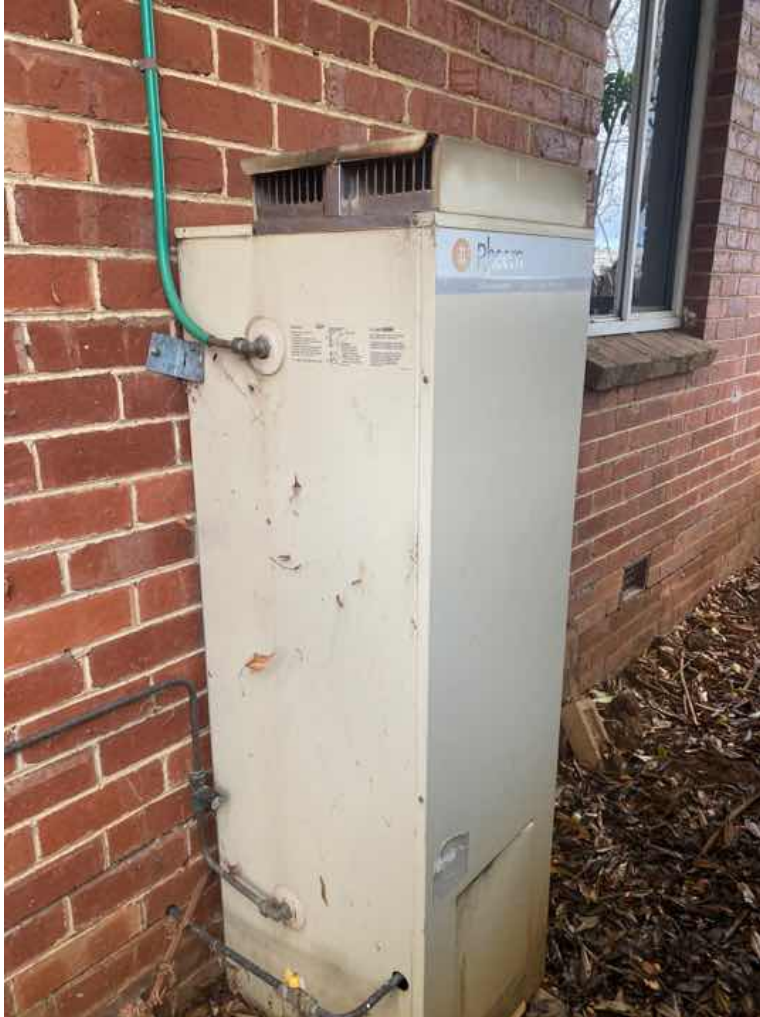
On visual inspection the hot water suit appears dilapidated. Anticipate a replacement in the not too distant future.

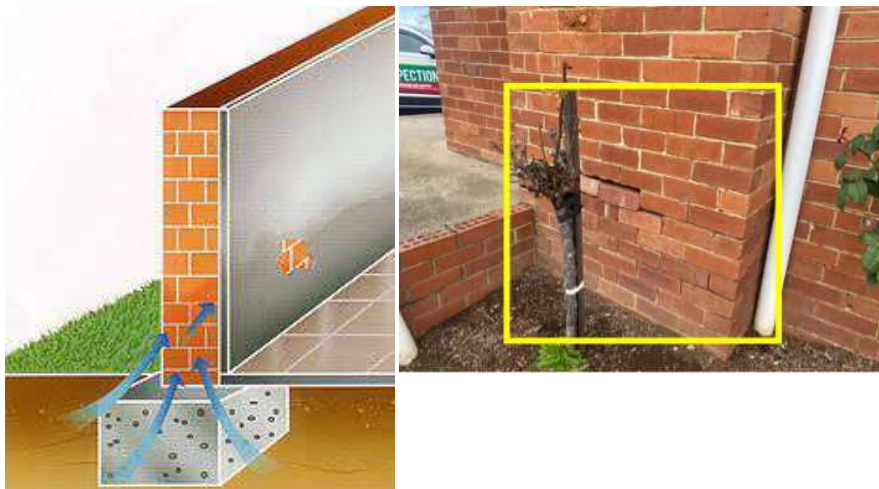
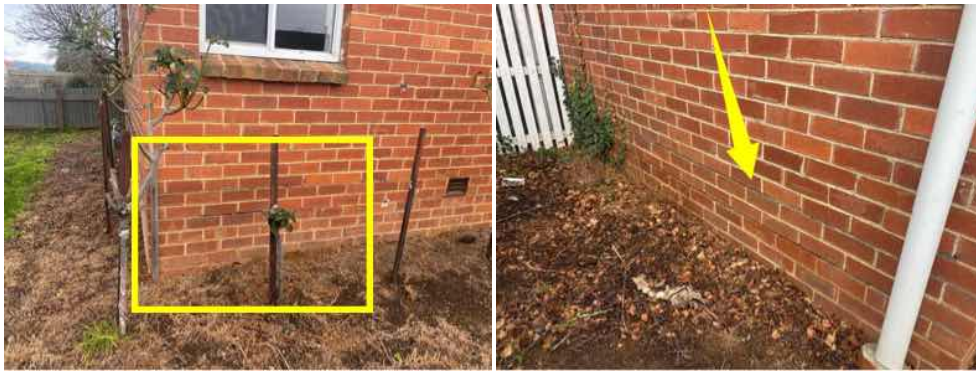
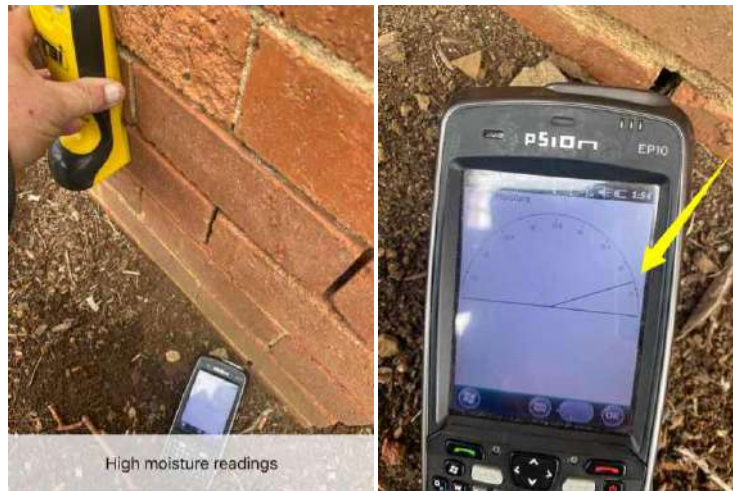
Salt residue & brick mortar deterioration on lower wall visible - Further investigation required. Recommendations: A specialist in this field should be engaged for advice and recommendations.

Salt residue on lower external wall visible - Salt residue can be associated with rising damp problems. Recommendations: Further investigation by a specialist in this field is recommended

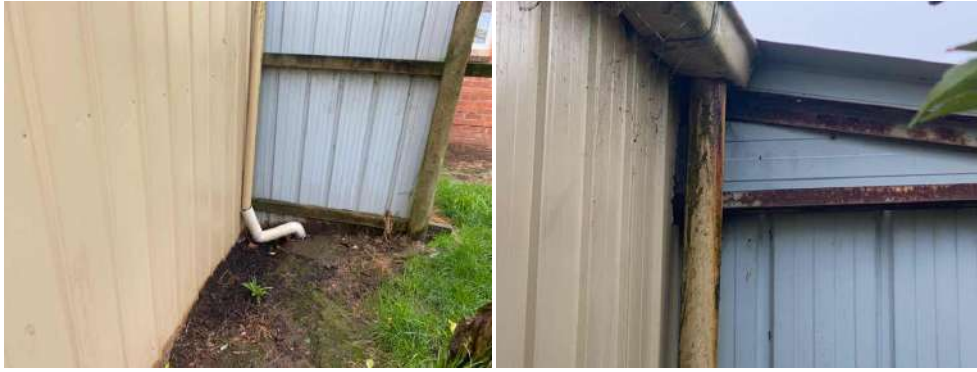
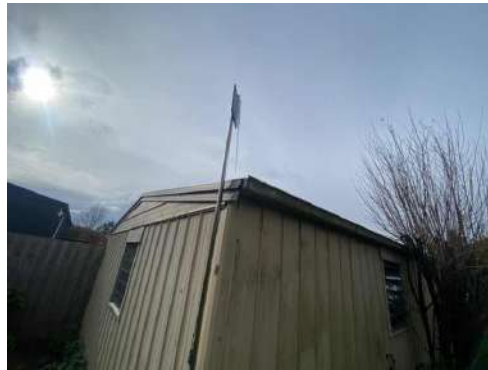
Gutter rust/penetrations - The guttering has excessive rust where leaking will occur. Recommendations: The gutters require replacement by a roof plumber to prevent further deterioration of cladding. Considered a Minor Defect

Debris visible have guttering cleaned every 6 months to prevent moisture issues.

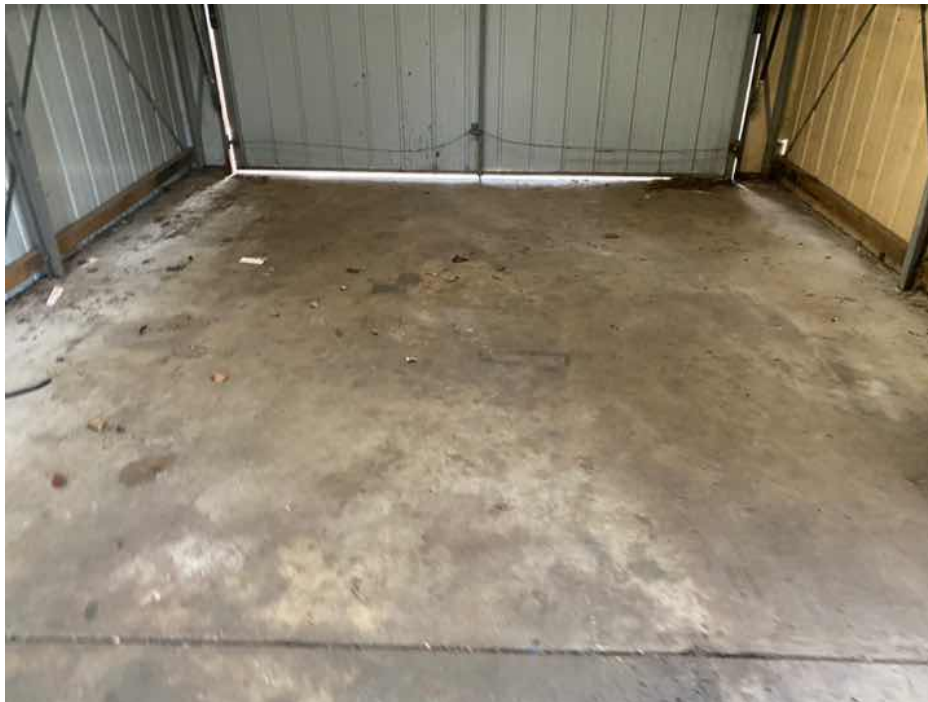
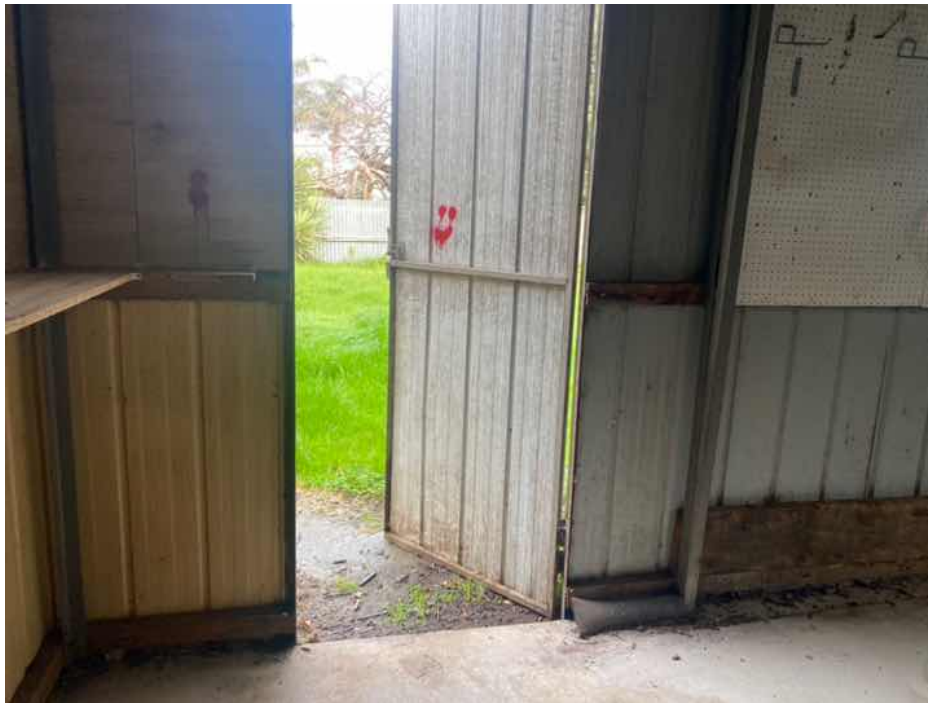
General age deterioration of the garage door/components. Recommendations: General repairs/maintenance as required.

Impact damage observed. Repairs/Replacement recommended.

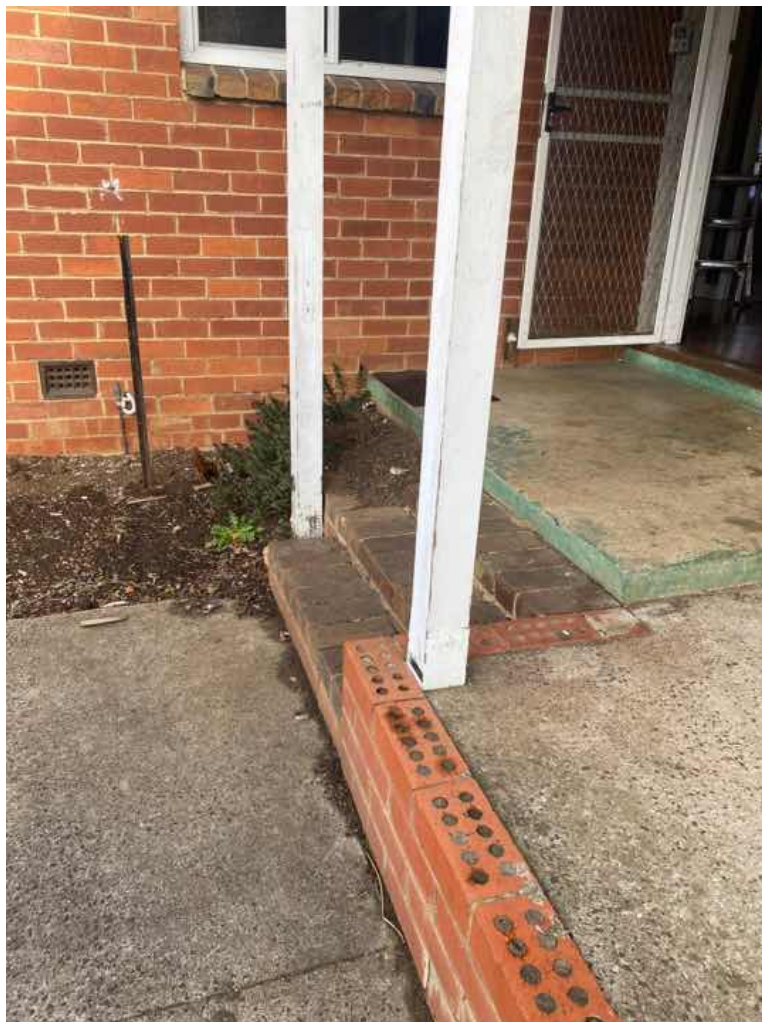
Paint Deterioration seek expert advice from painter

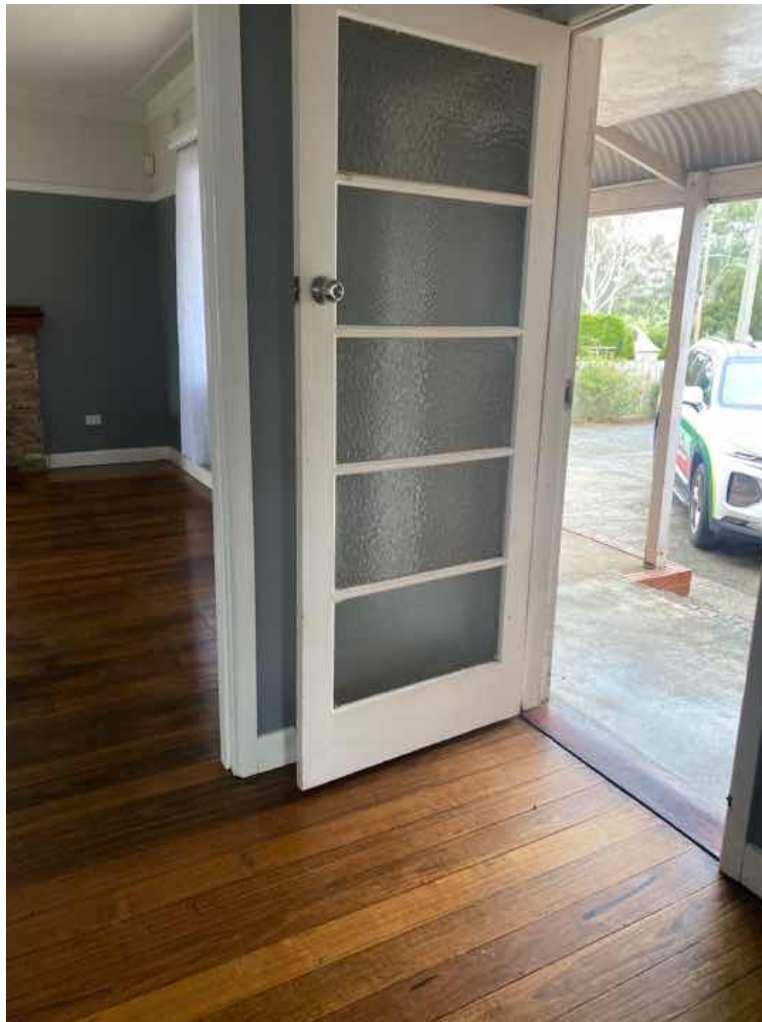
Door / frame deterioration - General age/damage has occurred to door frame, face or components. Recommendations: A qualified carpenter should be engaged for advice and recommendations.

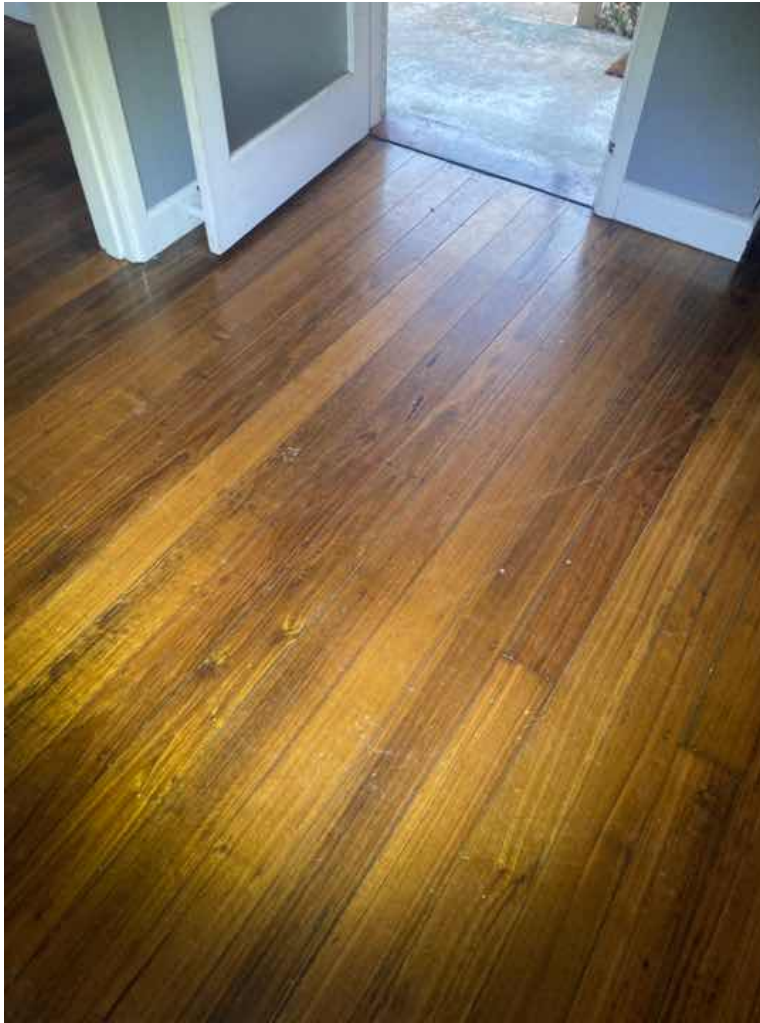
Wear & Tear is visible to flooring highly recommend a floor specialist to advise on care and maintenance to flooring for future.

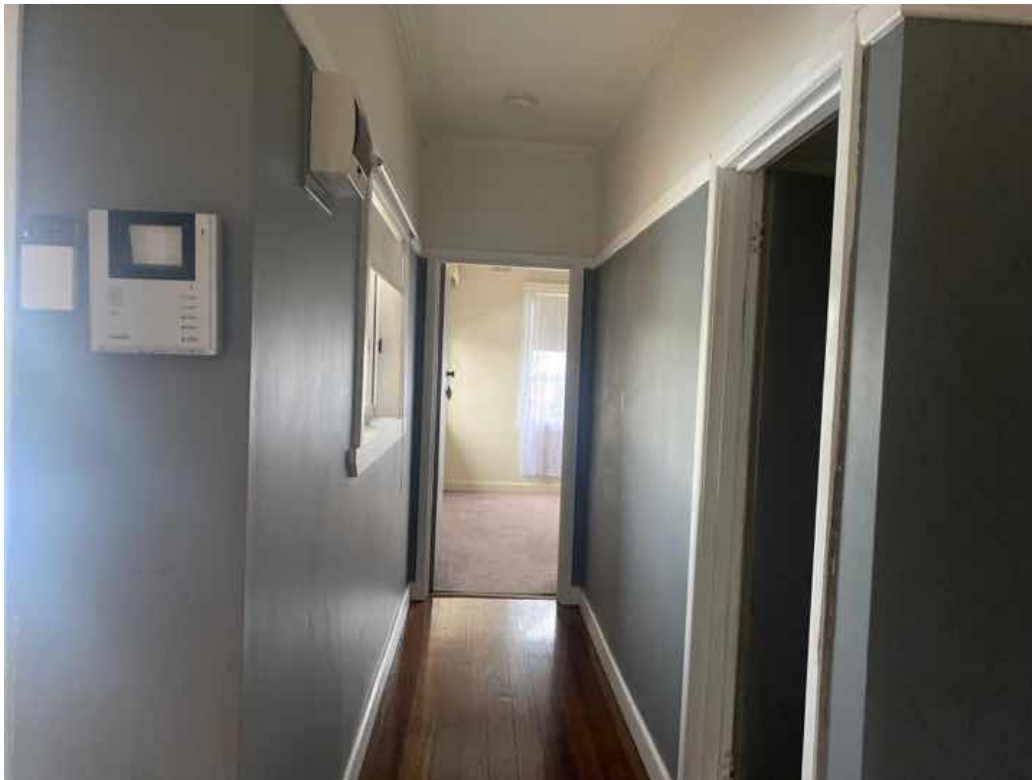
General ageing and/or denting and the like is evident on ceiling linings - Recommendations: A qualified painter should be engaged to assess and repair as required.

Ceiling paint flake/deterioration is evident. Recommendations: General maintenance / painting as required.

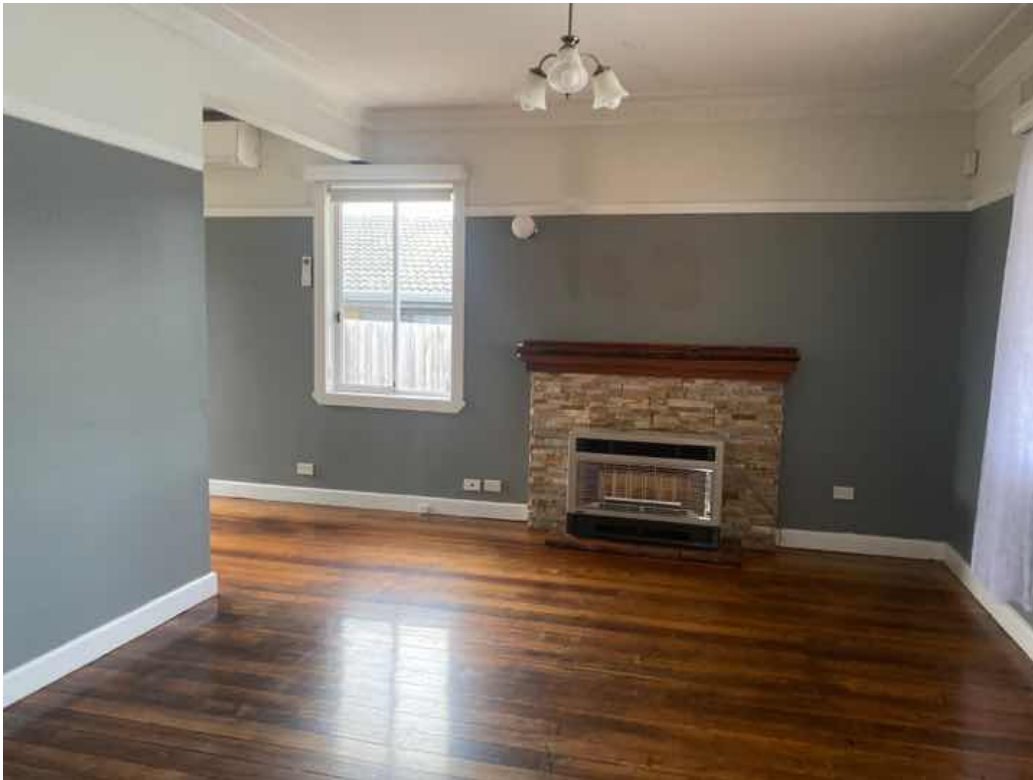
General ageing and/or denting and the like is evident on ceiling linings - Recommendations: A qualified painter should be engaged to assess and repair as required.

Incomplete Patch/Paint repairs noted. Call a licensed painter for repairs

Nail popping observed to the ceiling lining. This is a Safety Hazard And should be repaired as soon as possible by a licensed plasterer to avoid any unsafe conditions.

Ceiling paint flake/deterioration is evident. Recommendations: General maintenance / painting as required.

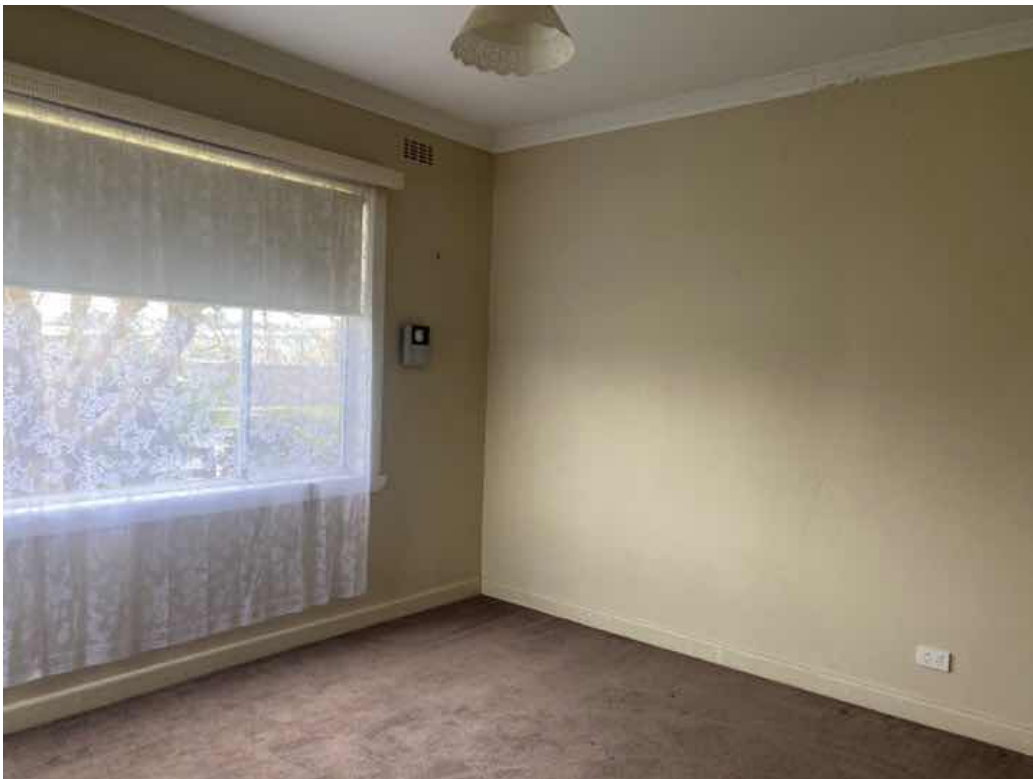
Door / frame deterioration - General age/damage has occurred to door frame, face or components.  
Recommendations: A qualified carpenter should be engaged for advice and recommendations.

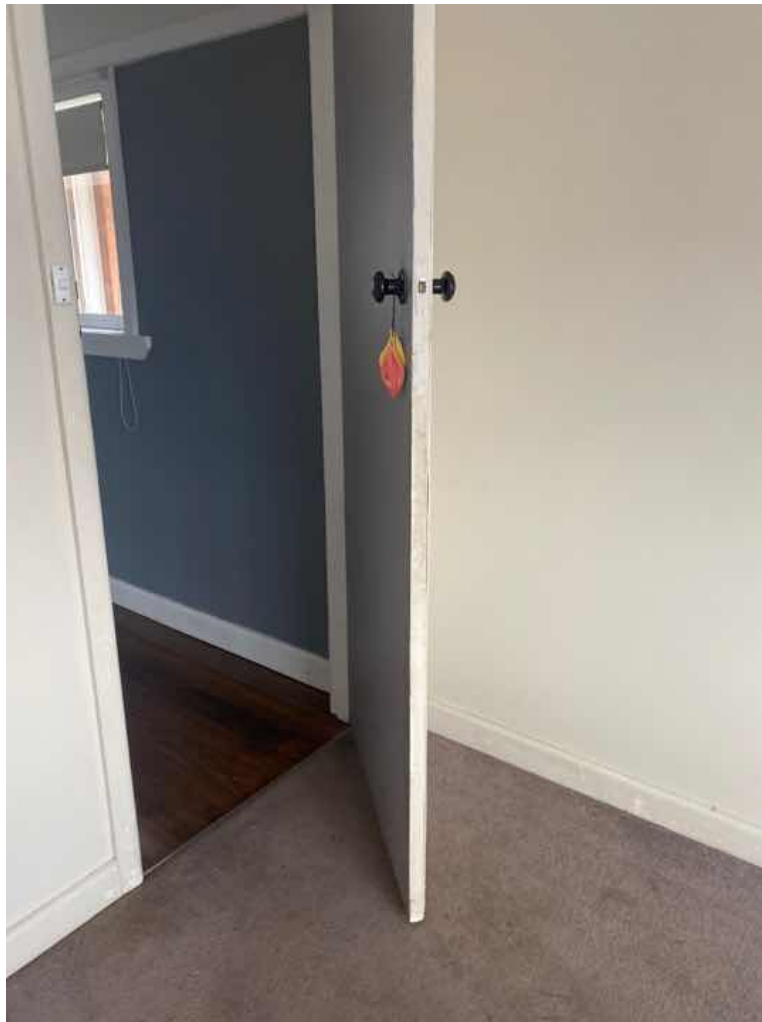
Settlement Cracks Noted . These are typical and generally patch and paint will suffice, however Monitoring these cracks advised for 12 months and if become wider or longer, you will need to contact a structural engineers to assess.

Incomplete Patch/Paint repairs noted. Call a licensed painter for repairs

Ceiling paint flake/deterioration is evident. Recommendations: General maintenance / painting as required.

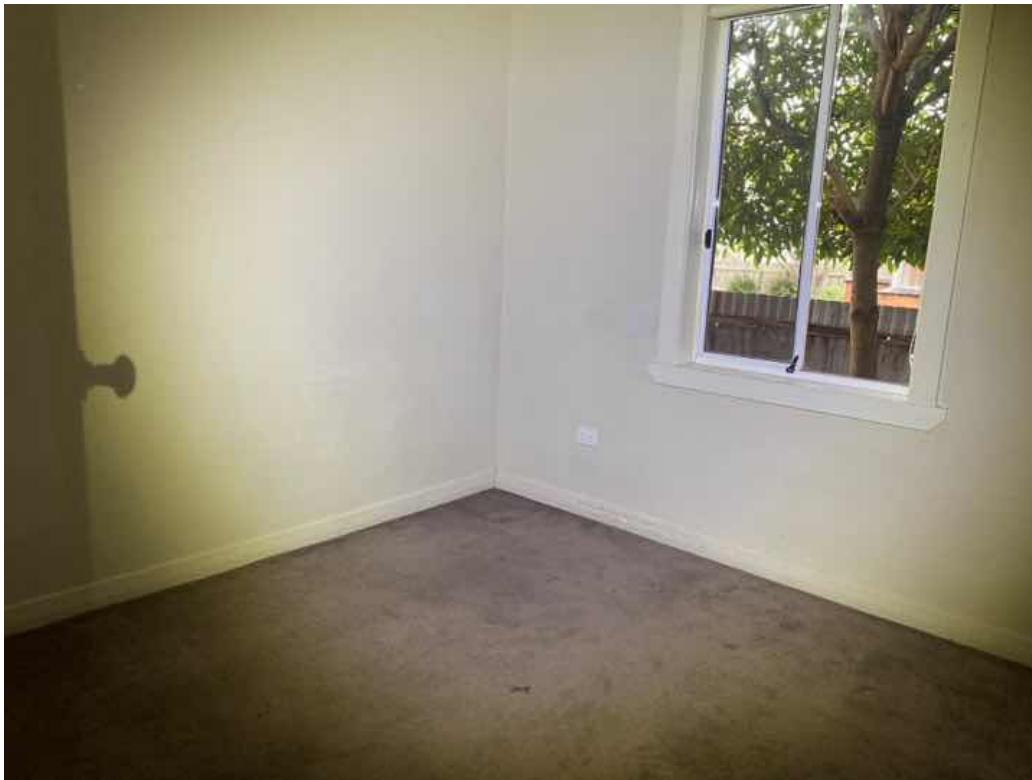
Door / frame deterioration - General age/damage has occurred to door frame, face or components. Recommendations: A qualified carpenter should be engaged for advice and recommendations.

Impact damage observed. Repairs / Replacement recommended

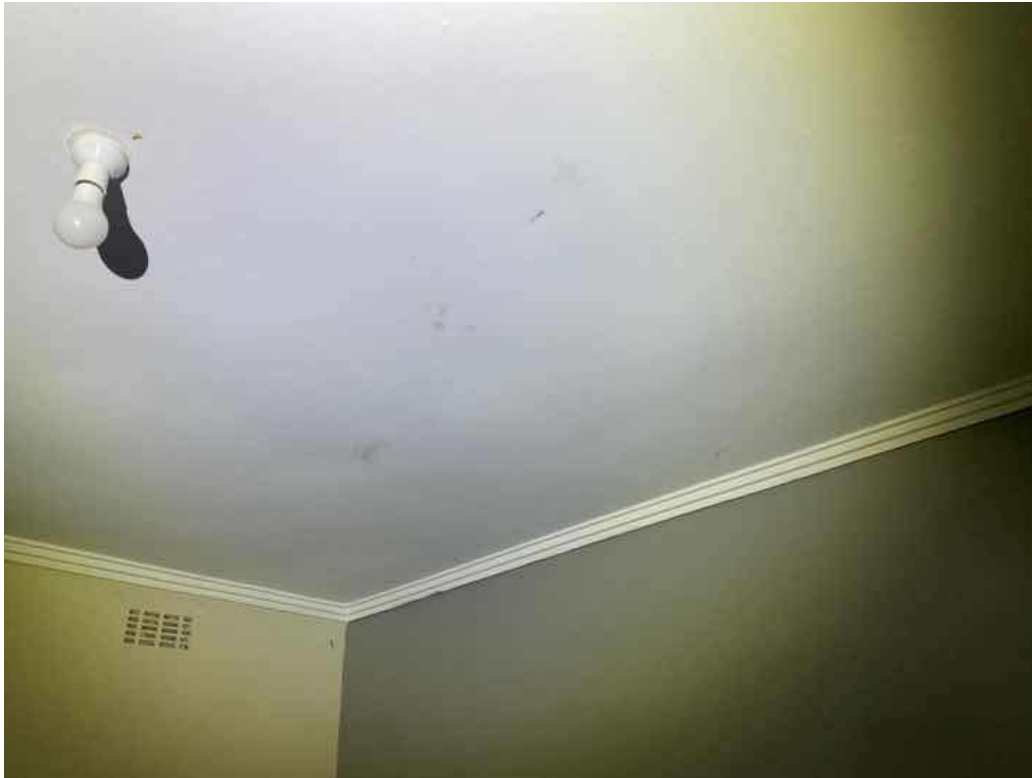
General ageing and/or denting and the like is evident on wall linings - Recommendations: A qualified painter should be engaged to assess and repair as required.

Impact damage noted. Contact a licensed plasterer for repairs.

Incomplete Patch/Paint repairs noted. Call a licensed painter for repairs

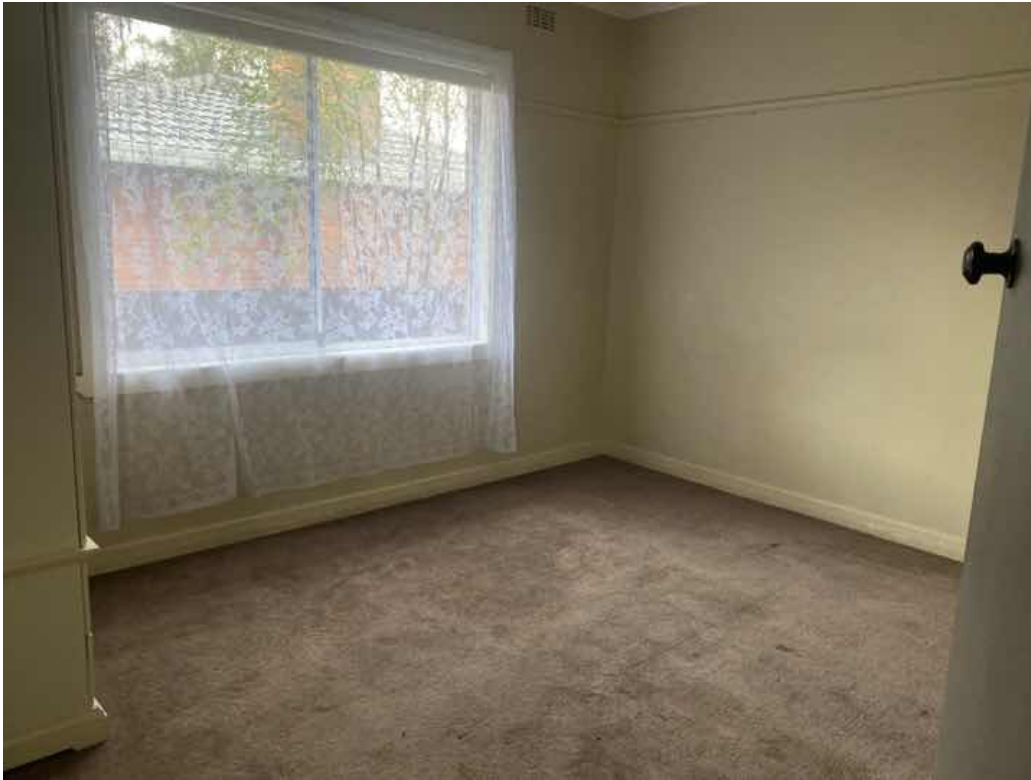
Door / frame deterioration - General age/damage has occurred to door frame, face or components.  
 Recommendations: A qualified carpenter should be engaged for advice and recommendations.

Uneven / out of square door frame - This can relate to some differential settlement in the footings, frame movement, age, expansion, shrinkage and the like. Recommendations: A qualified carpenter should be engaged for advice and recommendations.

Impact damage observed. Repairs / Replacement recommended

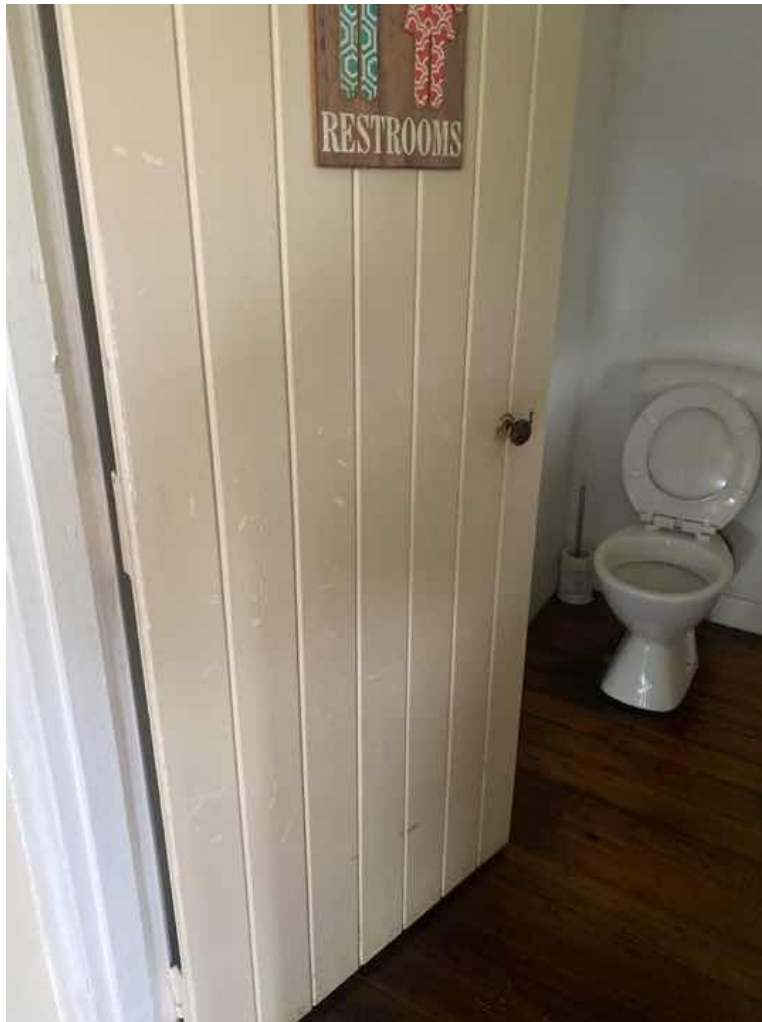
Settlement Cracks Noted. These are typical and generally patch and paint will suffice, however monitoring these cracks advised for 12 months and if become wider or longer, you will need to contact a structural engineers to assess.

Ceiling paint flake/deterioration is evident. Recommendations: General maintenance / painting as required.

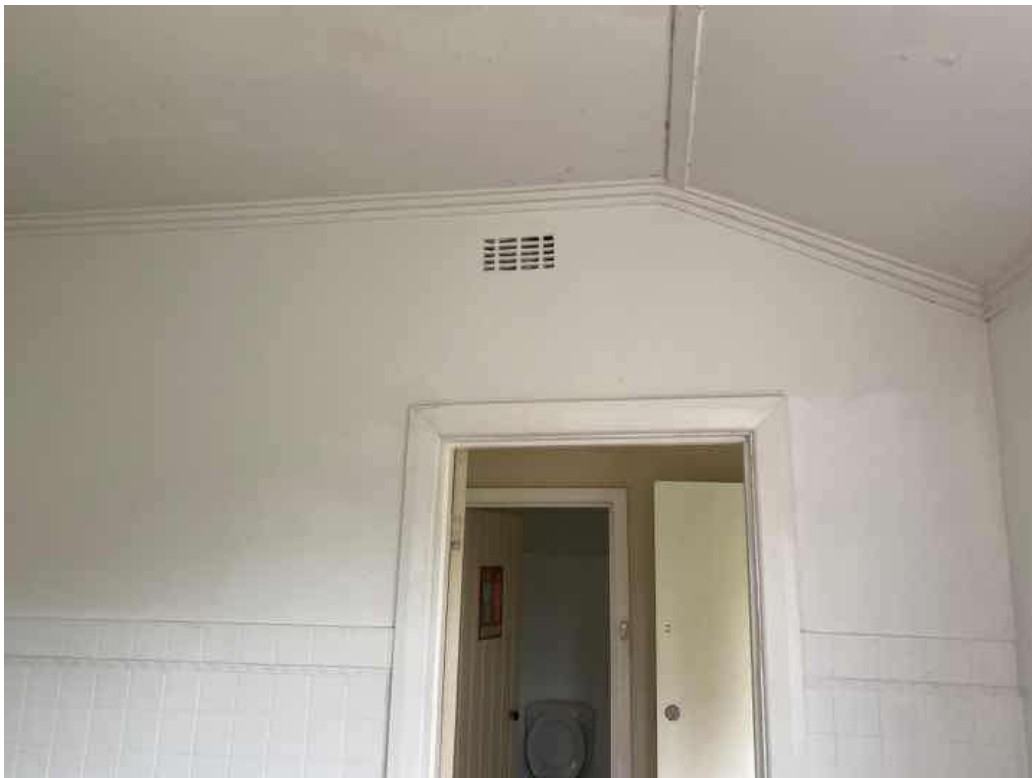
Door / frame deterioration - General age/damage has occurred to door frame, face or components.  
 Recommendations: A qualified carpenter should be engaged for advice and recommendations.

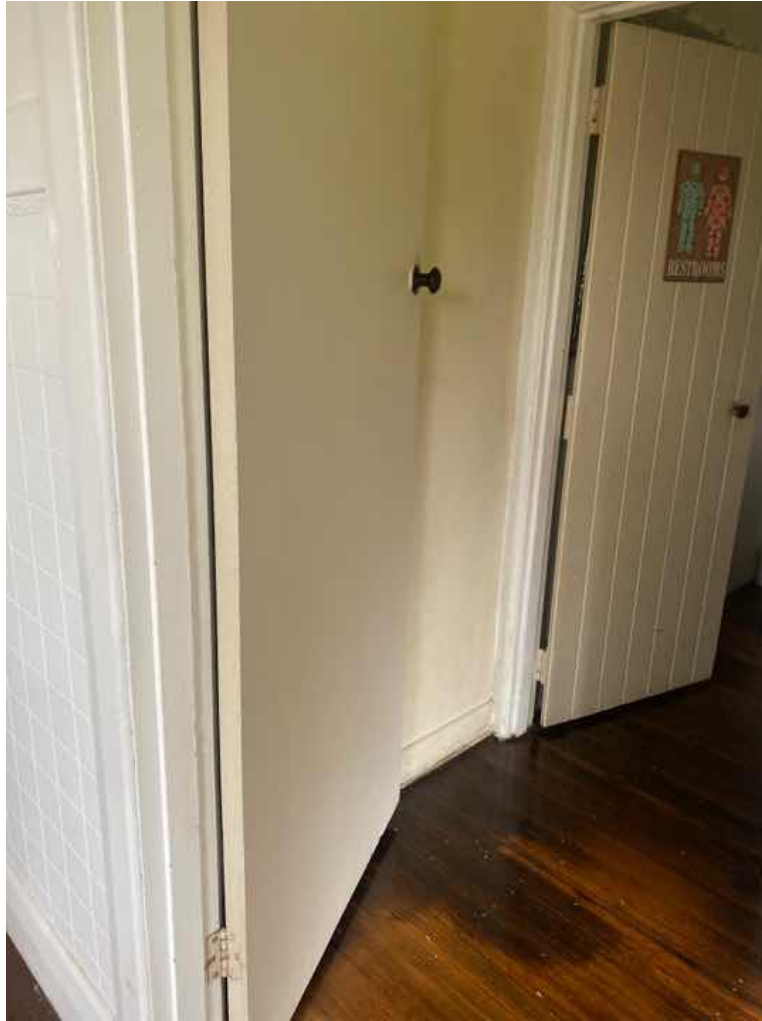
General age, wear and tear - Recommendations: General repair and maintenance advised.

Borer damage to floor linings - Some weakened boards may require assessment/replacement.  
 Recommendations: A qualified carpenter should be engaged for advice and recommendations.

Unevenness visible in floor - Floor linings may require removal to ascertain cause. Recommendations: A qualified carpenter should be engaged for advice and recommendations re levelling.

Squeaky floor boards noted. Re-fixing the floor boards may fix this issue. Seek expert advice from from a licensed builder.

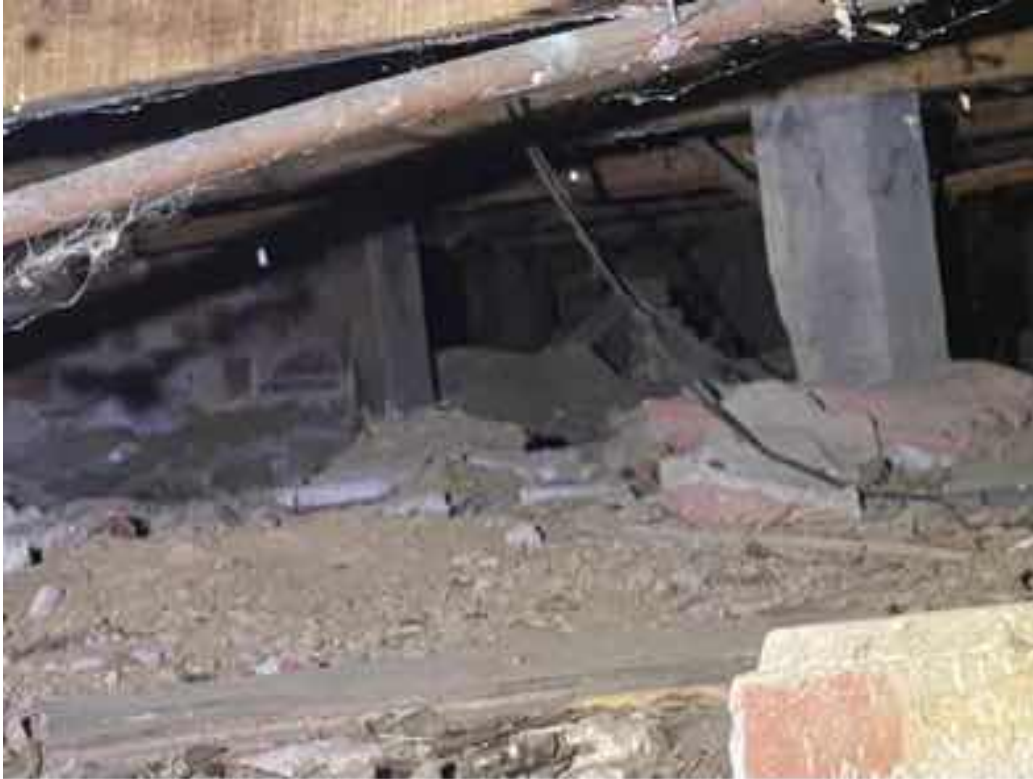
Low access restricted full visual inspection.
