**Home Inspections For A Better Peace Of Mind.**

**123 Homebuyer Road, Homebuyers Town, Victoria, 3000**

Report/Agreement #              Combined Building & Timber Pest Inspection Report  
 Inspection Date:                  02 Jan 2023  
 Inspection Time:                  07:00

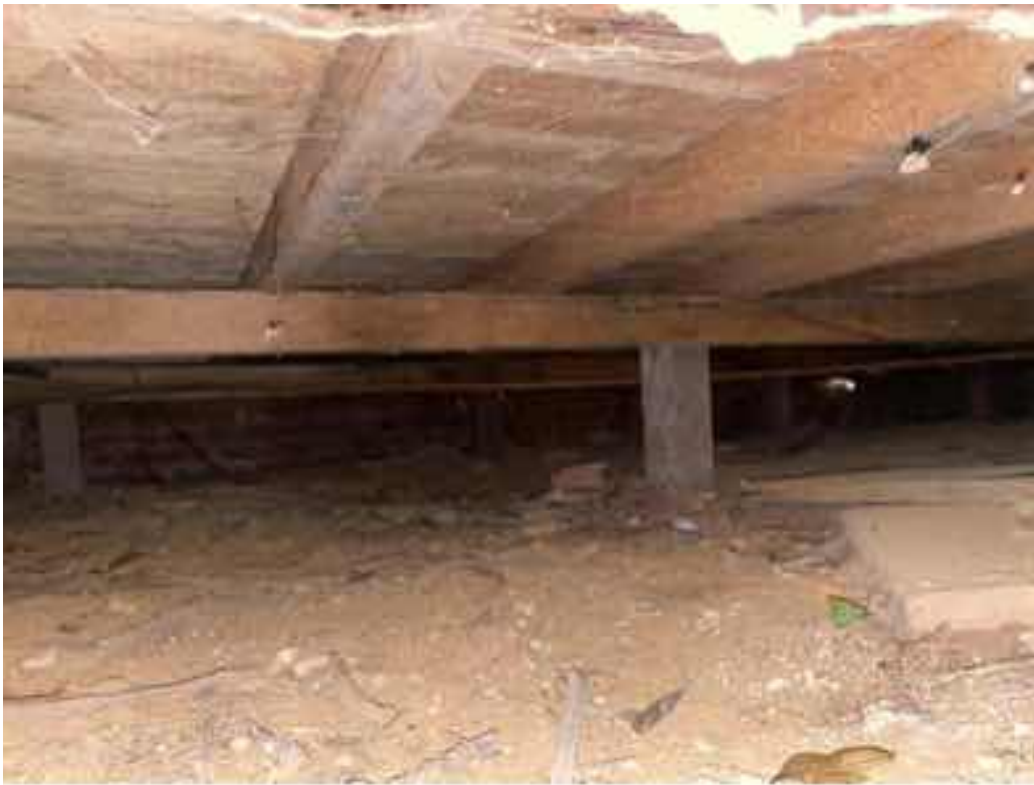
On inspection, defects were present that will require further assessing and recommendations by licensed and qualified trades persons, for example, a structural engineer, plumber, carpenter, electrician, plasterer may need to assess. Please read below for details.

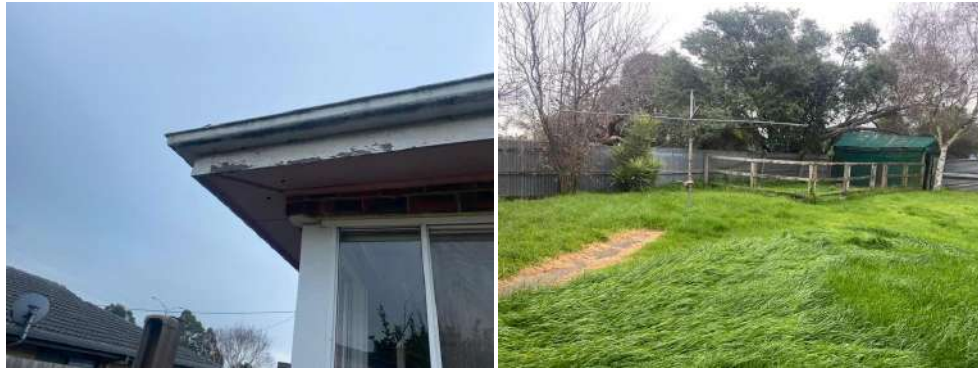
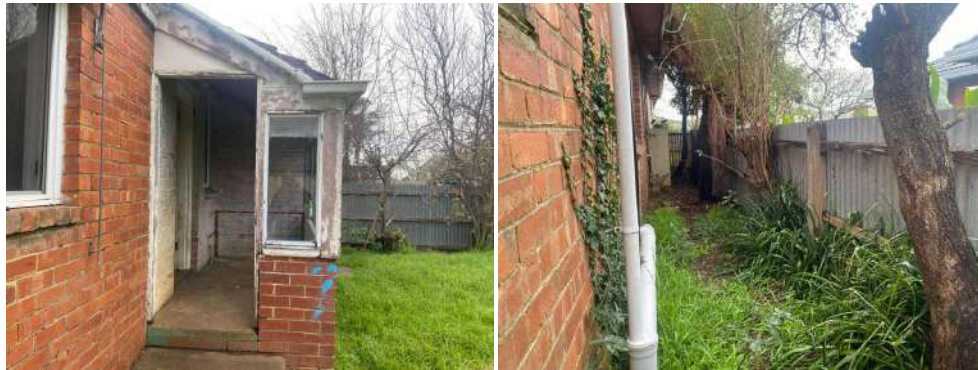
Yes, in the following areas ,  
Fascia and / or Barge board  
Window frame/s ,  
Door frames

Extent of rot damage is considered moderate to high

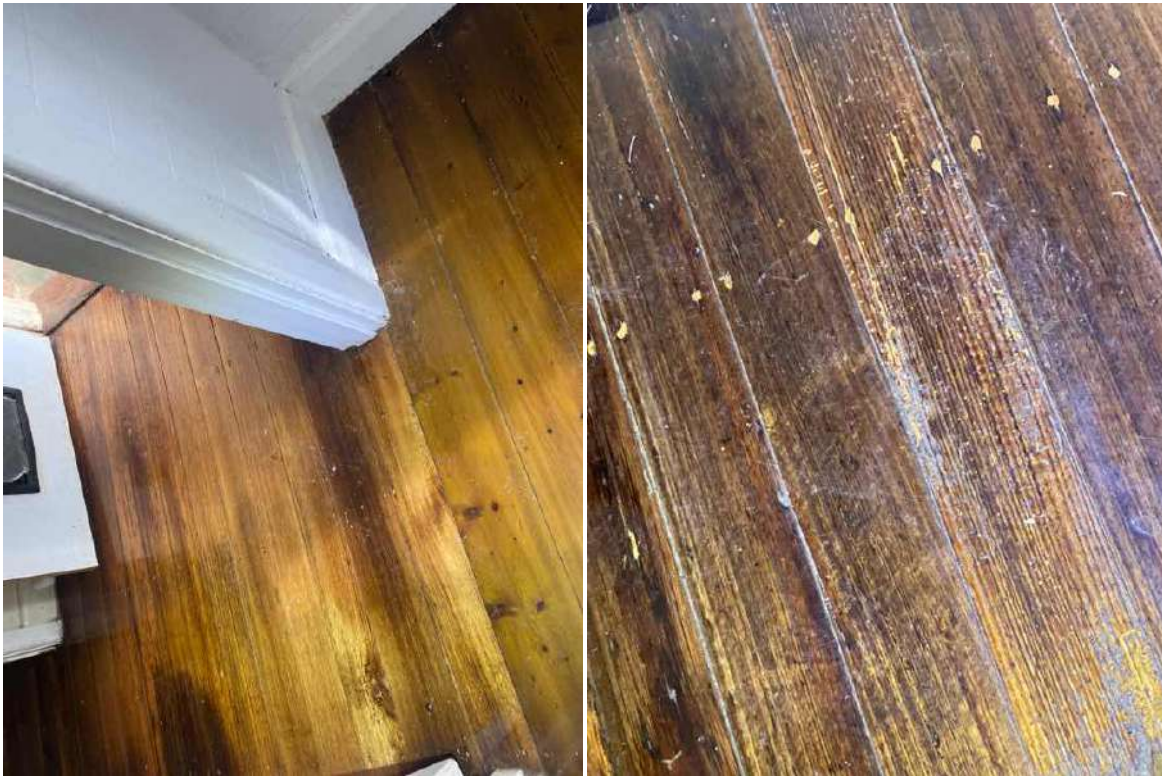
Large Timber pest infestation visible seek expert advice from a licensed builder for non-susceptible Timbers.

Major defect.

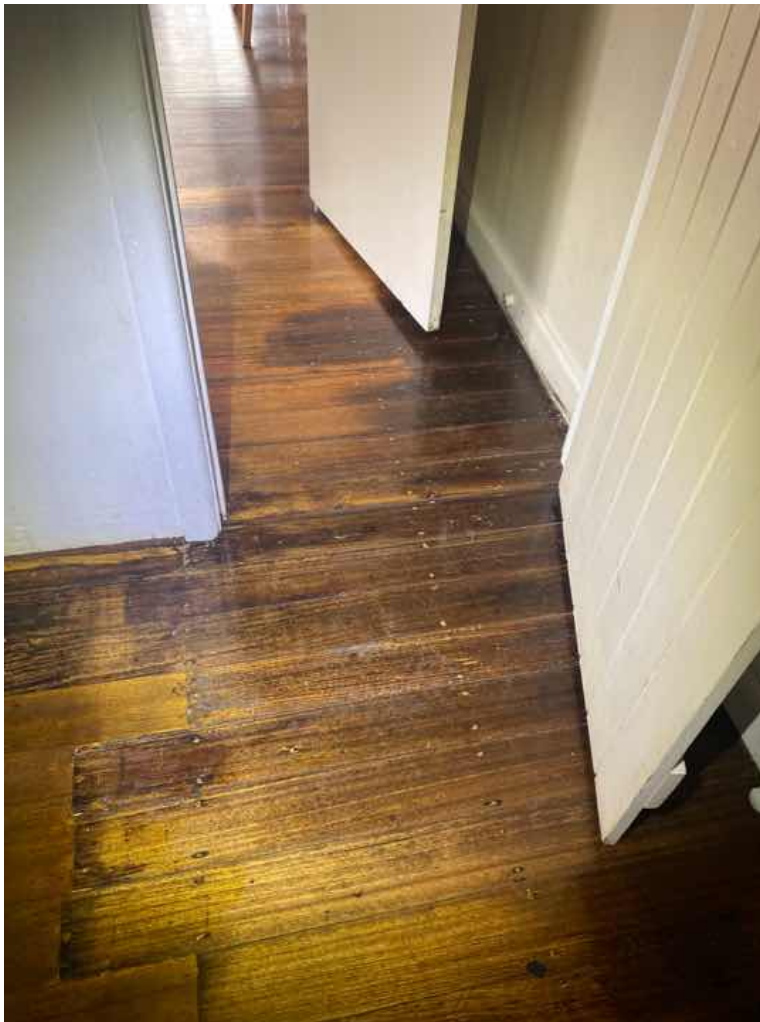
### **Moderate Damage was Found in**

Floor boards

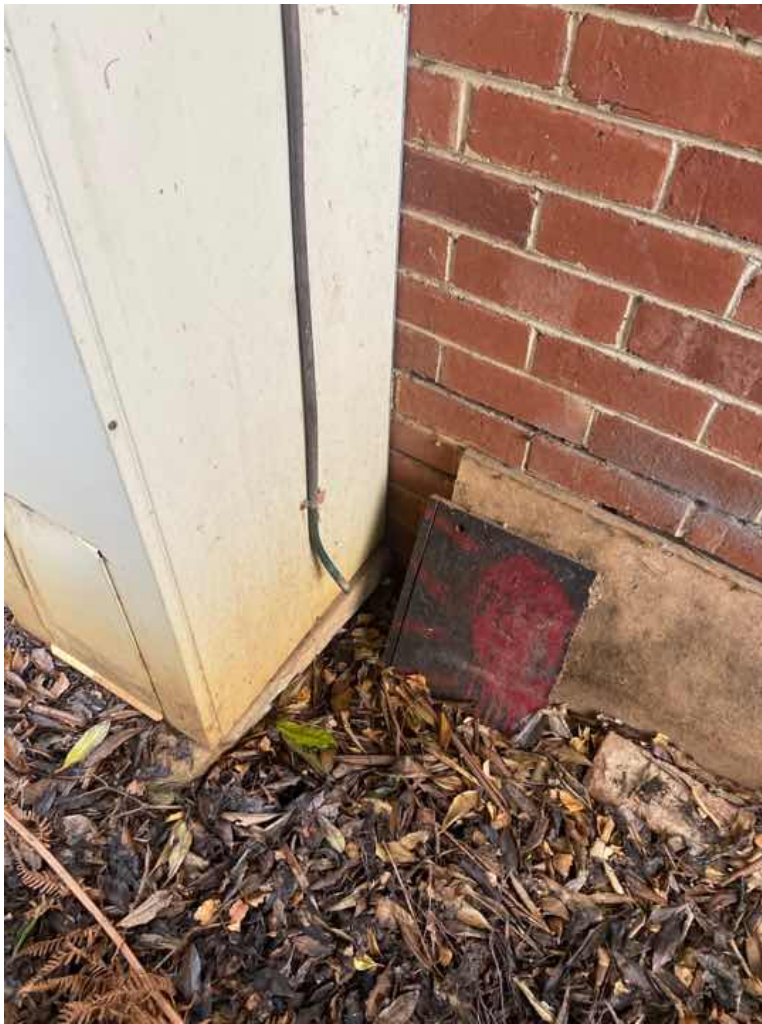
#### Was the overflow sufficiently drained

No - Divert hot water overflow away from the building perimeter

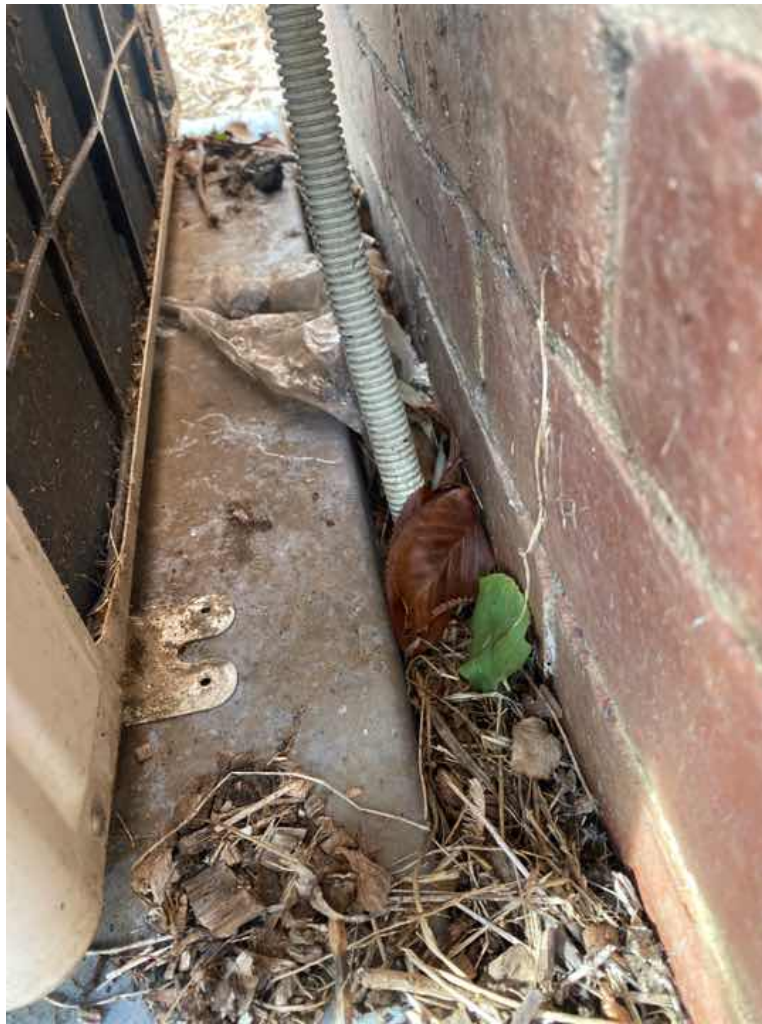
**Was the Air Conditioner Sufficiently Drained**

No - Divert A/C overflow away from the building perimeter

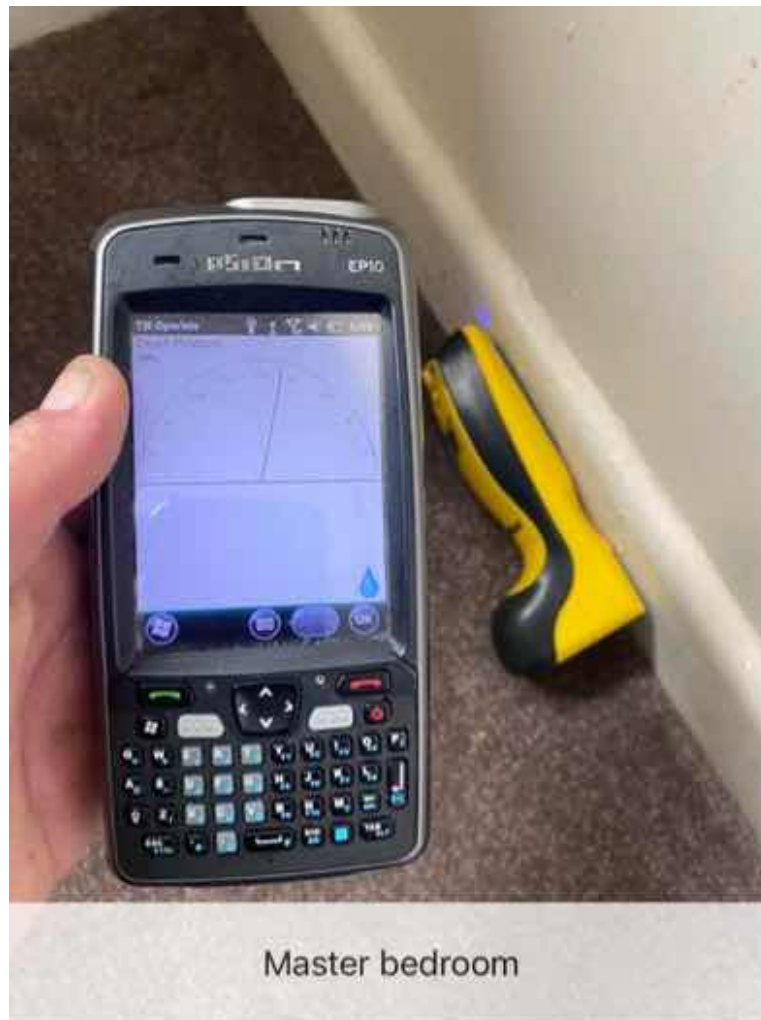
Master bedroom

At the time of the inspection moisture readings were high
